Access Compliance Report

Public Rights-of-Way

(Curb Ramps)

Intersection ID: N/A	Main Street: PINEVILLE-MATTHEWS_RD	Cross Street: N/A	Location: SE
ADA ID: 8C3BD7ED9973	Ramp Type: Perp	Initial Pass/Fail: Fail	Overall Compliance: No
		Severity Score: 10

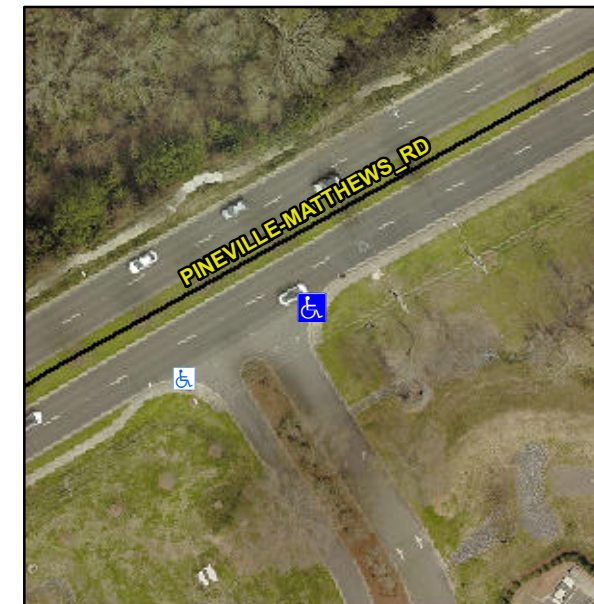
Not Found, R304.5.1, R304.5.3

Compliance	Description	Data	Compliance	Description	Data
N/A	Ramp Length (in)	58.0	Yes	Ramp Slope (%)	6.3
No	Ramp Width (in)	38.0	No	Ramp XSlope (%)	2.2
N/A	Flare Type LT	N/A	N/A	Flare Type RT	N/A
N/A	Flare Slope LT (%)	N/A	N/A	Flare Slope RT (%)	N/A
N/A	Flare Traversable LT?	N/A	N/A	Flare Traversable RT?	N/A
N/A	Landing Length (in)	N/A	N/A	DWS Provided?	N/A
N/A	Landing Width (in)	N/A	N/A	DWS Contrast?	N/A
N/A	Landing Slope (%)	N/A	N/A	DWS Length (in)	N/A
N/A	Landing X Slope (%)	N/A	N/A	DWS Full Width?	N/A
N/A	Landing Curb? (Y/N)	N/A	N/A	DWS Offset (in)	N/A
N/A	Shared Landing?	N/A			
N/A	Gutter Ponding?	N/A	N/A	Gutter Slope (%)	N/A
N/A	Gutter Lip Ht (in)	N/A	N/A	Gutter X Slope (%)	N/A
N/A	Painted X Walk1?	No	N/A	Painted X Walk2?	N/A
	X Walk 1 Direction	To W		X Walk 2 Direction	N/A
N/A	X Walk 1 Width (in)	N/A	N/A	X Walk 2 Width (in)	N/A
	X Walk 1 Slope (%)	2.2		X Walk 2 Slope (%)	N/A
	X Walk 1 X Slope (%)	0.2		X Walk 2 X Slope (%)	N/A

N/A	Ramp inside XWalk1?	N/A	N/A	Ramp inside XWalk2?	N/A
	Road Slope (%)	N/A	N/A	Clear Space?	N/A
	Road X Slope (%)	N/A	N/A	Clear Space to XWalk (in)	N/A
N/A	Any Obstructions?	N/A	N/A	Storm Grate/Utility Hazard?	N/A
	Obstruction Type			Storm Grate/Utility Type	
		N/A			N/A
			Yes	Surface Condition? (G/P)	Good

Remove & Replace Entire Ramp.
