Access Compliance Report

Public Rights-of-Way

(Curb Ramps)

Intersection ID: 10041968	Main Street: WINDSOR_CASTLE_LN	Cross Street: N/A	Location:	S
ADA ID: 8C3D8FB5C4B6	Ramp Type: PerpDiag	Initial Pass/Fail: Fail	Overall Compliance: No	Severity Score: 50
Codes/Mitigation Info/Possible Solution		Field Measurements/Component Compliance

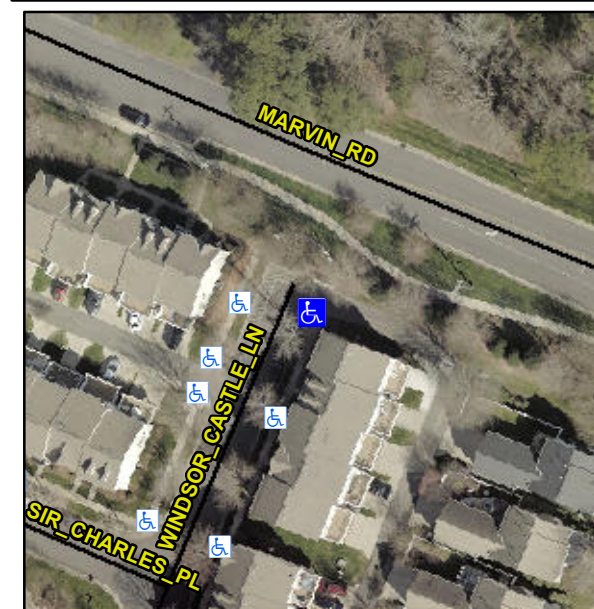
Compliance	Description	Data	Compliance	Description	Data
N/A	Ramp Length (in)	76.0	No	Ramp Slope (%)	12.0
Yes	Ramp Width (in)	48.0	No	Ramp XSlope (%)	7.8
N/A	Flare Type LT	N/A	N/A	Flare Type RT	N/A
N/A	Flare Slope LT (%)	N/A	N/A	Flare Slope RT (%)	N/A
N/A	Flare Traversable LT?	N/A	N/A	Flare Traversable RT?	N/A
N/A	Landing Length (in)	N/A	N/A	DWS Provided?	N/A
N/A	Landing Width (in)	N/A	N/A	DWS Contrast?	N/A
N/A	Landing Slope (%)	N/A	N/A	DWS Length (in)	N/A
N/A	Landing X Slope (%)	N/A	N/A	DWS Full Width?	N/A
N/A	Landing Curb? (Y/N)	N/A	N/A	DWS Offset (in)	N/A
N/A	Shared Landing?	N/A			
N/A	Gutter Ponding?	N/A	N/A	Gutter Slope (%)	N/A
N/A	Gutter Lip Ht (in)	N/A	N/A	Gutter X Slope (%)	N/A
N/A	Painted X Walk1?	No	N/A	Painted X Walk2?	No
	X Walk 1 Direction	To N		X Walk 2 Direction	To W
N/A	X Walk 1 Width (in)	N/A	N/A	X Walk 2 Width (in)	N/A
	X Walk 1 Slope (%)	2.4		X Walk 2 Slope (%)	1.0
	X Walk 1 X Slope (%)	2.0		X Walk 2 X Slope (%)	3.1

N/A	Ramp inside XWalk1?	N/A	N/A	Ramp inside XWalk2?	N/A
	Road Slope (%)	3.3	N/A	Clear Space?	N/A
	Road X Slope (%)	0.7	N/A	Clear Space to XWalk (in)	N/A
N/A	Any Obstructions?	N/A	N/A	Storm Grate/Utility Hazard?	N/A
	Obstruction Type			Storm Grate/Utility Type	
		N/A			N/A
			Yes	Surface Condition? (G/P)	Good

Possible Solutions:

Remove & Replace Curb Ramp With Two New Directional Ramps or Equivalent.
