Access Compliance Report Public Rights-of-Way (Curb Ramps)

Main Street: AYRSLEY TOWN BV **Cross Street: N/A** Location: NE Intersection ID: 10020275 Ramp Type: BlendTrans1 Initial Pass/Fail: Fail **Overall Compliance: No Severity Score:** ADA ID: 8C404AD9C599 8.75

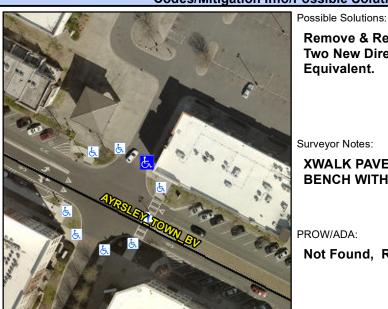
XWALK PAVERS, RESTURANT BENCH WITHIN LT FL

Not Found, R304.5.1

ENTRANCE Street 1 Name Stop Condition-Street 1 StopSign Street 2 Name N/A Stop Condition-Street 2 N/A Remove & Replace Curb Ramp With Two New Directional Ramps or Equivalent.
