Access Compliance Report

Public Rights-of-Way

(Curb Ramps)

Intersection ID: 32317	Main Street: BRIDGEVIEW_LN	Cross Street: NEW_PROVIDENCE_LN	Location: NE
ADA ID: 8C417C1FE347	Ramp Type: PerpDiag	Initial Pass/Fail: Fail	Overall Compliance: No
Severity Score: 33.75			
Codes/Mitigation Info/Possible Solution		Field Measurements/Component Compliance

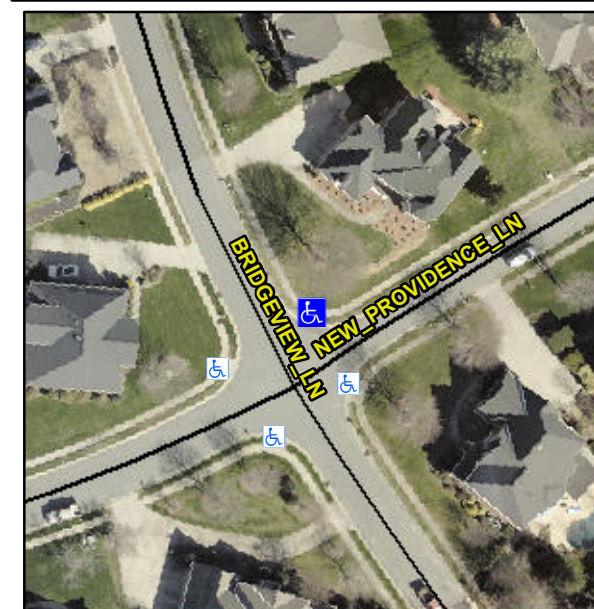
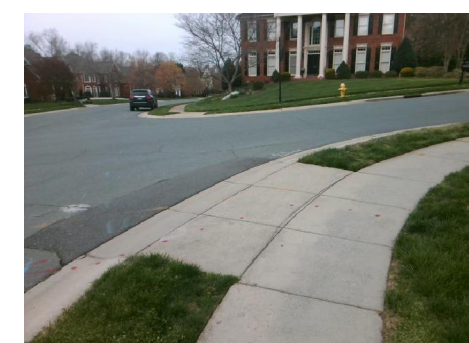
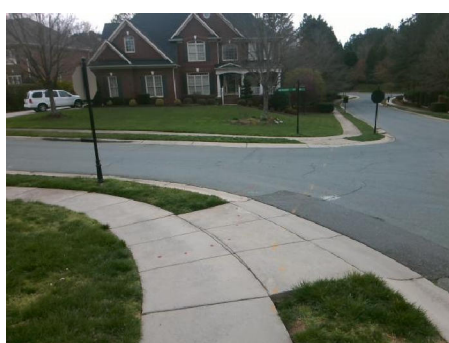
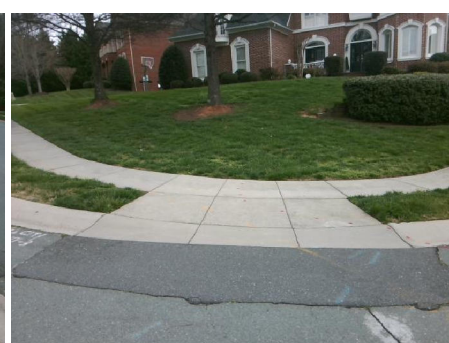
Not Found, R304.5.1, R304.2.2, R304.5.3

Compliance	Description	Data	Compliance	Description	Data
N/A	Ramp Length (in)	46.5	No	Ramp Slope (%)	8.4
No	Ramp Width (in)	43.0	No	Ramp XSlope (%)	6.7
N/A	Flare Type LT	N/A	N/A	Flare Type RT	N/A
N/A	Flare Slope LT (%)	N/A	N/A	Flare Slope RT (%)	N/A
N/A	Flare Traversable LT?	N/A	N/A	Flare Traversable RT?	N/A
N/A	Landing Length (in)	N/A	N/A	DWS Provided?	N/A
N/A	Landing Width (in)	N/A	N/A	DWS Contrast?	N/A
N/A	Landing Slope (%)	N/A	N/A	DWS Length (in)	N/A
N/A	Landing X Slope (%)	N/A	N/A	DWS Full Width?	N/A
N/A	Landing Curb? (Y/N)	N/A	N/A	DWS Offset (in)	N/A
N/A	Shared Landing?	N/A			
N/A	Gutter Ponding?	N/A	N/A	Gutter Slope (%)	N/A
N/A	Gutter Lip Ht (in)	N/A	N/A	Gutter X Slope (%)	N/A
N/A	Painted X Walk1?	No	N/A	Painted X Walk2?	No
	X Walk 1 Direction	To SW		X Walk 2 Direction	To SE
N/A	X Walk 1 Width (in)	N/A	N/A	X Walk 2 Width (in)	N/A
	X Walk 1 Slope (%)	1.4		X Walk 2 Slope (%)	6.6
	X Walk 1 X Slope (%)	7.6		X Walk 2 X Slope (%)	0.1

N/A	Ramp inside XWalk1?	N/A	N/A	Ramp inside XWalk2?	N/A
	Road Slope (%)	5.5	N/A	Clear Space?	N/A
	Road X Slope (%)	5.2	N/A	Clear Space to XWalk (in)	N/A
N/A	Any Obstructions?	N/A	N/A	Storm Grate/Utility Hazard?	N/A
	Obstruction Type			Storm Grate/Utility Type	
		N/A			N/A
			Yes	Surface Condition? (G/P)	Good

Remove & Replace Curb Ramp With Two New Directional Ramps or Equivalent.
