Access Compliance Report Public Rights-of-Way (Curb Ramps)

Intersection ID: 19986 Main Street: ARCHDALE_DR Cross Street: SOUTH_BV Location: SE ADA ID: 8C445904463E Ramp Type: Perp Initial Pass/Fail: Fail **Overall Compliance: No Severity Score:** 12.5

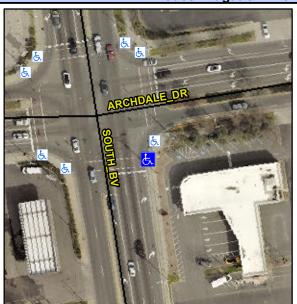
/Possible Solution			Field Measurements/Component Compliance					
Possible Solutions:			Compliance Description		Data	oliance Description	Data	
Remove & Replace Entir	Entire Ramı	o.	N/A	Ramp Length (in)	28.0	No	Ramp Slope (%)	8.5
·	•		Yes	Ramp Width (in)	48.0	Yes	Ramp XSlope (%)	0.3
			N/A	Flare Type LT	N/A	N/A	Flare Type RT	N/A
			N/A	Flare Slope LT (%)	N/A	N/A	Flare Slope RT (%)	N/A
			N/A	Flare Traversable LT?	N/A	N/A	Flare Traversable RT?	N/A
			N/A	Landing Length (in)	N/A	N/A	DWS Provided?	N/A
Surveyor Notes:			N/A	Landing Width (in)	N/A	N/A	DWS Contrast?	N/A
N/A			N/A	Landing Slope (%)	N/A	N/A	DWS Length (in)	N/A
			N/A	Landing X Slope (%)	N/A	N/A	DWS Full Width?	N/A
			N/A	Landing Curb? (Y/N)	N/A	N/A	DWS Offset (in)	N/A
			N/A	Shared Landing?	N/A			
PROW/ADA:			N/A	Gutter Ponding?	N/A	N/A	Gutter Slope (%)	N/A
Not Found, R304.2.2	2		N/A	Gutter Lip Ht (in)	N/A	N/A	Gutter X Slope (%)	N/A
·			N/A	Painted X Walk1?	Yes	N/A	Painted X Walk2?	N/A

X Walk 1 Direction	To W		X Walk 2 Direction	N/A
			N/A	X Walk 1 Width (in)	112.0	N/A	X Walk 2 Width (in)	N/A
				X Walk 1 Slope (%)	2.9		X Walk 2 Slope (%)	N/A
				X Walk 1 X Slope (%)	1.1		X Walk 2 X Slope (%)	N/A
			N/A	Ramp inside XWalk1?	Yes	N/A	Ramp inside XWalk2?	N/A
				Road Slope (%)	N/A	N/A	Clear Space?	N/A
				Road X Slope (%)	N/A	N/A	Clear Space to XWalk (in)	N/A
			N/A	Any Obstructions?	N/A	N/A	Storm Grate/Utility Hazard?	N/A
Total Cost:	\$	1850.00		Obstruction Type			Storm Grate/Utility Type	
					N/A			N/A
						Yes	Surface Condition? (G/P)	Good

Codes/Mitigation Info/Possible Solution
