Access Compliance Report

Public Rights-of-Way

(Curb Ramps)

Intersection ID: N/A	Main Street: SIKES_PL	Cross Street: N/A	Location: SE
ADA ID: 8C4A0A7820E9	Ramp Type: Perp	Initial Pass/Fail: Fail	Overall Compliance: No
Severity Score: 21.25			
Codes/Mitigation Info/Possible Solution		Field Measurements/Component Compliance

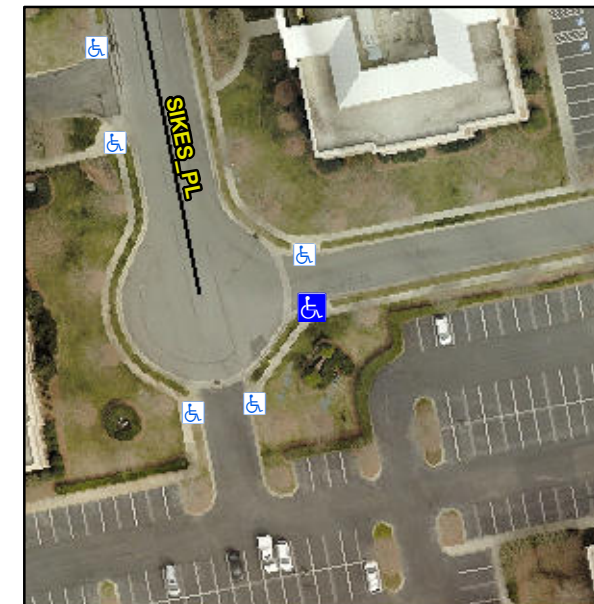
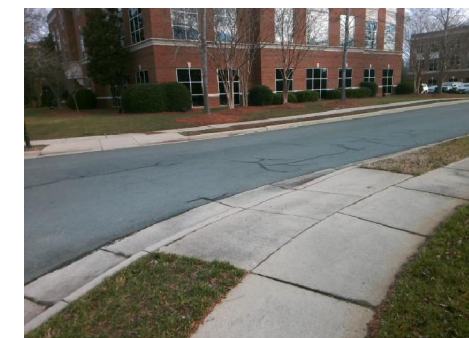
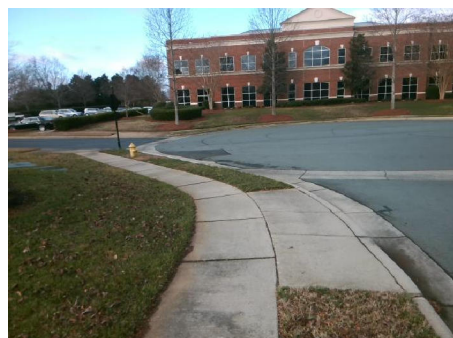
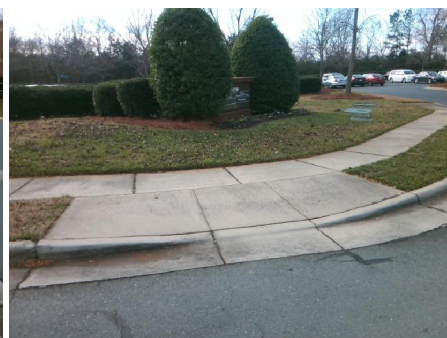
Compliance	Description	Data	Compliance	Description	Data
N/A	Ramp Length (in)	51.0	No	Ramp Slope (%)	9.3
No	Ramp Width (in)	44.5	Yes	Ramp XSlope (%)	0.9
N/A	Flare Type LT	N/A	N/A	Flare Type RT	N/A
N/A	Flare Slope LT (%)	N/A	N/A	Flare Slope RT (%)	N/A
N/A	Flare Traversable LT?	N/A	N/A	Flare Traversable RT?	N/A
N/A	Landing Length (in)	N/A	N/A	DWS Provided?	N/A
N/A	Landing Width (in)	N/A	N/A	DWS Contrast?	N/A
N/A	Landing Slope (%)	N/A	N/A	DWS Length (in)	N/A
N/A	Landing X Slope (%)	N/A	N/A	DWS Full Width?	N/A
N/A	Landing Curb? (Y/N)	N/A	N/A	DWS Offset (in)	N/A
N/A	Shared Landing?	N/A			
N/A	Gutter Ponding?	N/A	N/A	Gutter Slope (%)	N/A
N/A	Gutter Lip Ht (in)	1.0	N/A	Gutter X Slope (%)	N/A
N/A	Painted X Walk1?	No	N/A	Painted X Walk2?	N/A
	X Walk 1 Direction	To N		X Walk 2 Direction	N/A
N/A	X Walk 1 Width (in)	N/A	N/A	X Walk 2 Width (in)	N/A
	X Walk 1 Slope (%)	0.2		X Walk 2 Slope (%)	N/A
	X Walk 1 X Slope (%)	1.2		X Walk 2 X Slope (%)	N/A

N/A	Ramp inside XWalk1?	N/A	N/A	Ramp inside XWalk2?	N/A
	Road Slope (%)	N/A	N/A	Clear Space?	N/A
	Road X Slope (%)	N/A	N/A	Clear Space to XWalk (in)	N/A
N/A	Any Obstructions?	N/A	N/A	Storm Grate/Utility Hazard?	N/A
	Obstruction Type			Storm Grate/Utility Type	
		N/A			N/A
			Yes	Surface Condition? (G/P)	Good

Possible Solutions:

Remove & Replace Entire Ramp.
