Access Compliance Report

Public Rights-of-Way

(Curb Ramps)

Intersection ID: 53165	Main Street: DIXIE_RIVER_RD	Cross Street: N/A	Location: SW
ADA ID: 8C4B61B5A0B0	Ramp Type: Perp	Initial Pass/Fail: Fail	Overall Compliance: No
		Severity Score: 12.5

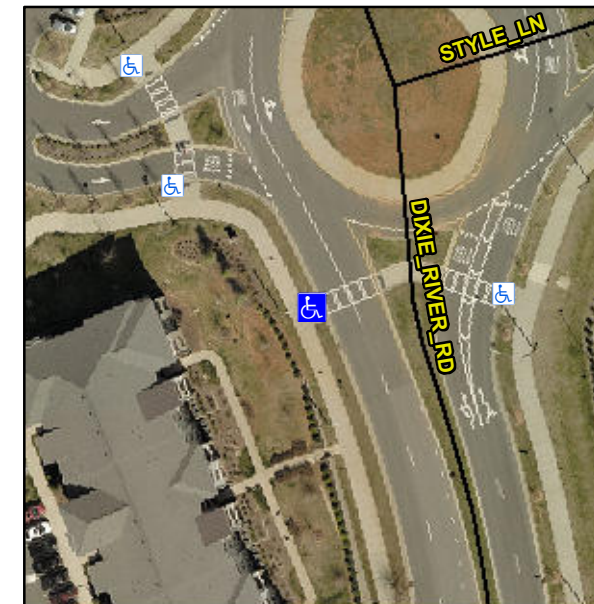
Not Found, R304.5.3

Compliance	Description	Data	Compliance	Description	Data
N/A	Ramp Length (in)	96.0	Yes	Ramp Slope (%)	7.9
Yes	Ramp Width (in)	48.0	No	Ramp XSlope (%)	6.7
N/A	Flare Type LT	N/A	N/A	Flare Type RT	N/A
N/A	Flare Slope LT (%)	N/A	N/A	Flare Slope RT (%)	N/A
N/A	Flare Traversable LT?	N/A	N/A	Flare Traversable RT?	N/A
N/A	Landing Length (in)	N/A	N/A	DWS Provided?	N/A
N/A	Landing Width (in)	N/A	N/A	DWS Contrast?	N/A
N/A	Landing Slope (%)	N/A	N/A	DWS Length (in)	N/A
N/A	Landing X Slope (%)	N/A	N/A	DWS Full Width?	N/A
N/A	Landing Curb? (Y/N)	N/A	N/A	DWS Offset (in)	N/A
N/A	Shared Landing?	N/A			
N/A	Gutter Ponding?	N/A	N/A	Gutter Slope (%)	N/A
N/A	Gutter Lip Ht (in)	N/A	N/A	Gutter X Slope (%)	N/A
N/A	Painted X Walk1?	Yes	N/A	Painted X Walk2?	N/A
	X Walk 1 Direction	To E		X Walk 2 Direction	N/A
N/A	X Walk 1 Width (in)	115.0	N/A	X Walk 2 Width (in)	N/A
	X Walk 1 Slope (%)	2.5		X Walk 2 Slope (%)	N/A
	X Walk 1 X Slope (%)	5.6		X Walk 2 X Slope (%)	N/A

Possible Solutions:

Remove & Replace Entire Ramp.
