# Access Compliance Report

## Public Rights-of-Way

### (Curb Ramps)

| Intersection ID: 14455 | Main Street: EAST_BV | Cross Street: WINTHROP_AV | Location: SW |

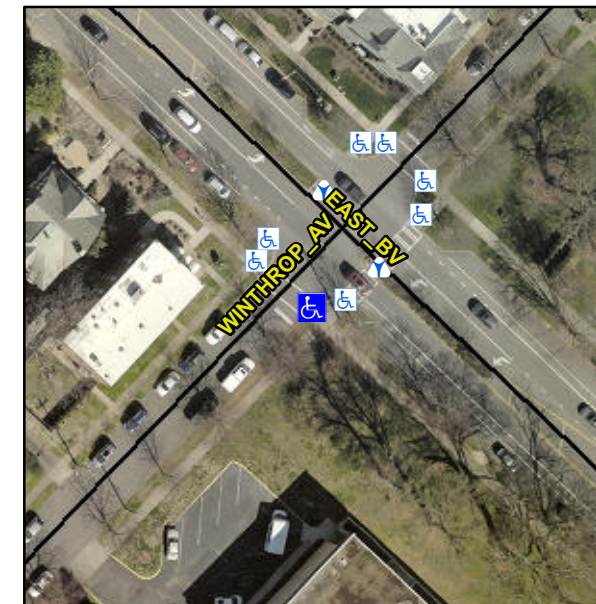
**Not Found, R304.5.3, R305.2**

| Compliance | Description | Data | Compliance | Description | Data |
|---|---|---|---|---|---|
| No | Landing X Slope (%) | 2.2 | Yes | DWS Full Width? | Yes |
| N/A | Landing Curb? (Y/N) | No | No | DWS Offset (in) | 8.0 |
| Yes | Gutter Lip Ht (in) | 0.0 | No | Gutter X Slope (%) | 3.6 |
| | | | No | Curb Slope (%) | 9.0 |

**Remove & Replace Curb Ramp With Two New Directional Ramps or Equivalent. Remove & Replace Gutter.**

Total Cost: \$ 3950.00
