Access Compliance Report

Public Rights-of-Way

(Curb Ramps)

Intersection ID: 30474	Main Street: CREEK_TURN_DR	Cross Street: GOLDEN_VIEW_DR	Location: NE
ADA ID: 8C58BEEFEFF7	Ramp Type: BlendTrans1	Initial Pass/Fail: Fail	Overall Compliance: No
		Severity Score: 17.5

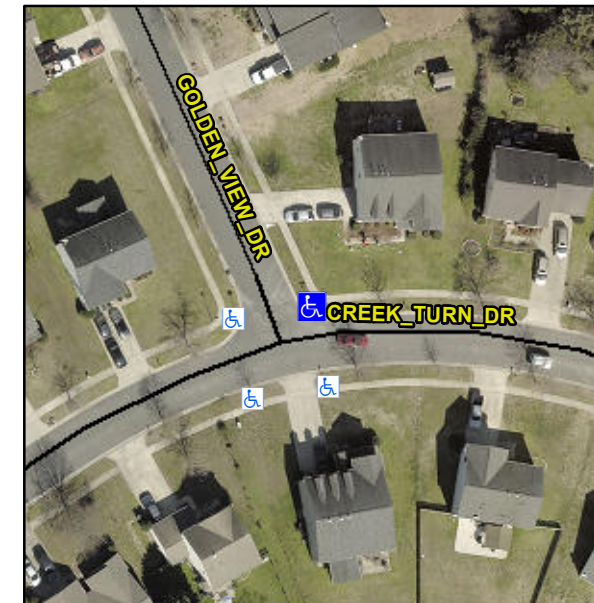
Compliance	Description	Data	Compliance	Description	Data
N/A	Ramp Length (in)	83.0	Yes	BlendTrans Slope (%)	2.1
No	Ramp Width (in)	35.0	Yes	BlendTrans XSlope (%)	0.4
N/A	Flare Type LT	N/A	N/A	Flare Type RT	N/A
N/A	Flare Slope LT (%)	N/A	N/A	Flare Slope RT (%)	N/A
N/A	Flare Traversable LT?	N/A	N/A	Flare Traversable RT?	N/A
N/A	Landing Length (in)	N/A	N/A	DWS Provided?	N/A
N/A	Landing Width (in)	N/A	N/A	DWS Contrast?	N/A
N/A	Landing Slope (%)	N/A	N/A	DWS Length (in)	N/A
N/A	Landing X Slope (%)	N/A	N/A	DWS Full Width?	N/A
N/A	Landing Curb? (Y/N)	N/A	N/A	DWS Offset (in)	N/A
N/A	Shared Landing?	N/A			
N/A	Gutter Ponding?	N/A	N/A	Gutter Slope (%)	N/A
N/A	Gutter Lip Ht (in)	N/A	N/A	Gutter X Slope (%)	N/A
N/A	Painted X Walk1?	No	N/A	Painted X Walk2?	No
	X Walk 1 Direction	To W		X Walk 2 Direction	To SE
	X Walk 1 Width (in)	N/A		X Walk 2 Width (in)	N/A
	X Walk 1 Slope (%)	4.2		X Walk 2 Slope (%)	4.4
	X Walk 1 X Slope (%)	4.5		X Walk 2 X Slope (%)	2.5

N/A	Ramp inside XWalk1?	N/A	N/A	Ramp inside XWalk2?	N/A
	Road Slope (%)	1.3		Clear Space?	N/A
	Road X Slope (%)	3.9	N/A	Clear Space to XWalk (in)	N/A
N/A	Any Obstructions?	N/A	N/A	Storm Grate/Utility Hazard?	N/A
	Obstruction Type			Storm Grate/Utility Type	
		N/A			N/A
			Yes	Surface Condition? (G/P)	Good
			N/A	Curb Slope (%)	3.4

Possible Solutions:

Remove & Replace Curb Ramp With Two New Directional Ramps or Equivalent.

R304.5.1

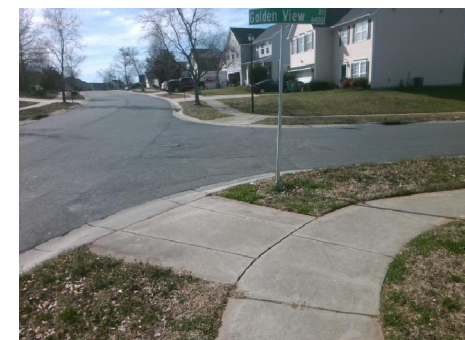
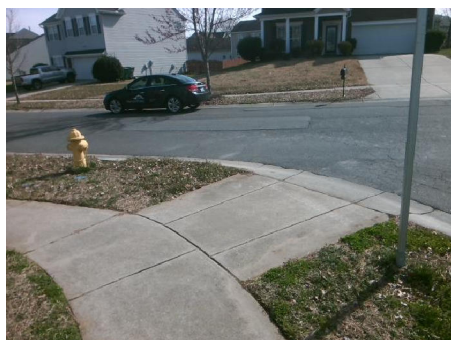
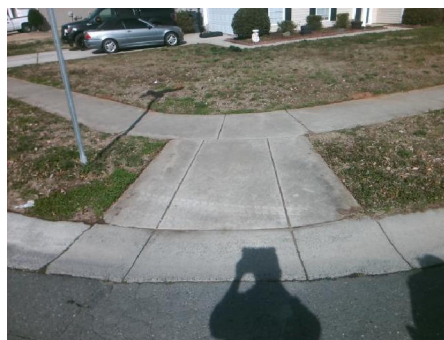
Street 1 Name **GOLDEN VIEW DR**
 Stop Condition-Street 1 **StopSign**
 Street 2 Name **CREEK TURN DR**
 Stop Condition-Street 2 **None**
