Access Compliance Report

Public Rights-of-Way

(Curb Ramps)

Intersection ID: 10035582	Main Street: REAMES_RD	Cross Street: N/A	Location: E
ADA ID: 8C590ACD6D71	Ramp Type: Perp	Initial Pass/Fail: Fail	Overall Compliance: No
Codes/Mitigation Info/Possible Solution		Field Measurements/Component Compliance	
Severity Score: 8.75

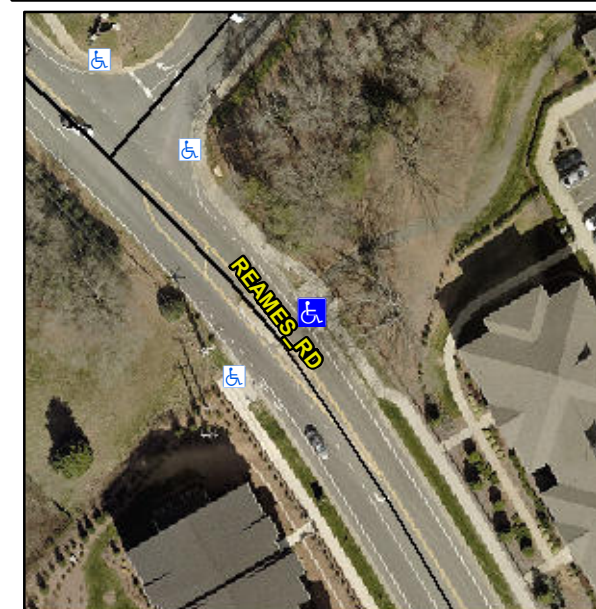
Not Found, R304.5.1

Compliance	Description	Data	Compliance	Description	Data
N/A	Ramp Length (in)	83.0	Yes	Ramp Slope (%)	7.7
No	Ramp Width (in)	36.0	Yes	Ramp XSlope (%)	1.6
N/A	Flare Type LT	N/A	N/A	Flare Type RT	N/A
N/A	Flare Slope LT (%)	N/A	N/A	Flare Slope RT (%)	N/A
N/A	Flare Traversable LT?	N/A	N/A	Flare Traversable RT?	N/A
N/A	Landing Length (in)	N/A	N/A	DWS Provided?	N/A
N/A	Landing Width (in)	N/A	N/A	DWS Contrast?	N/A
N/A	Landing Slope (%)	N/A	N/A	DWS Length (in)	N/A
N/A	Landing X Slope (%)	N/A	N/A	DWS Full Width?	N/A
N/A	Landing Curb? (Y/N)	N/A	N/A	DWS Offset (in)	N/A
N/A	Shared Landing?	N/A			
N/A	Gutter Ponding?	N/A	N/A	Gutter Slope (%)	N/A
N/A	Gutter Lip Ht (in)	N/A	N/A	Gutter X Slope (%)	N/A
N/A	Painted X Walk1?	No	N/A	Painted X Walk2?	N/A
	X Walk 1 Direction	To W		X Walk 2 Direction	N/A
N/A	X Walk 1 Width (in)	N/A	N/A	X Walk 2 Width (in)	N/A
	X Walk 1 Slope (%)	5.3		X Walk 2 Slope (%)	N/A
	X Walk 1 X Slope (%)	1.3		X Walk 2 X Slope (%)	N/A

N/A	Ramp inside XWalk1?	N/A	N/A	Ramp inside XWalk2?	N/A
	Road Slope (%)	N/A	N/A	Clear Space?	N/A
	Road X Slope (%)	N/A	N/A	Clear Space to XWalk (in)	N/A
N/A	Any Obstructions?	N/A	N/A	Storm Grate/Utility Hazard?	N/A
	Obstruction Type			Storm Grate/Utility Type	
		N/A			N/A
			Yes	Surface Condition? (G/P)	Good

Possible Solutions:

Remove & Replace Entire Ramp.
