Access Compliance Report

Public Rights-of-Way

(Curb Ramps)

Intersection ID: 48998	Main Street: FALLON_FARM_RD	Cross Street: STEELECROFT_PY	Location: SW
ADA ID: 8C6604576C74	Ramp Type: Perp	Initial Pass/Fail: Fail	Overall Compliance: No Severity Score: 13.75

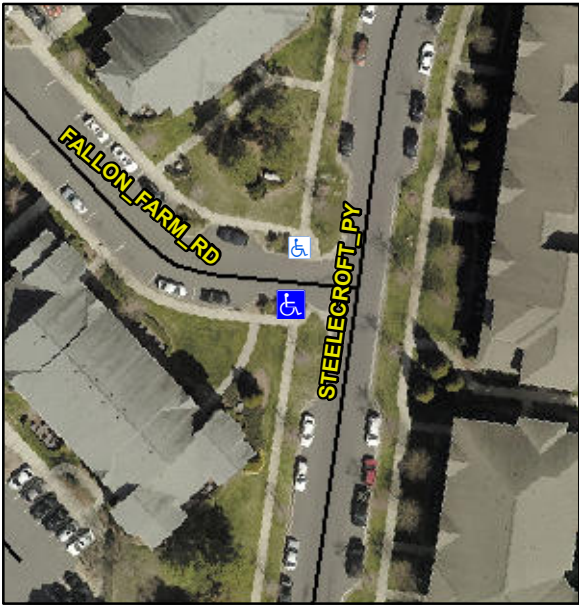
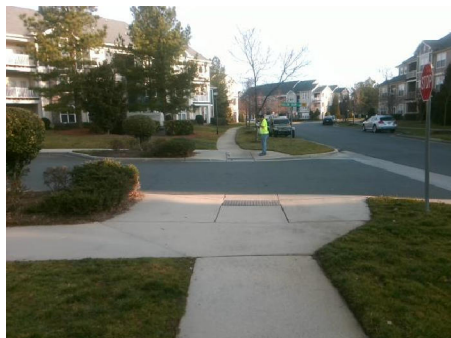
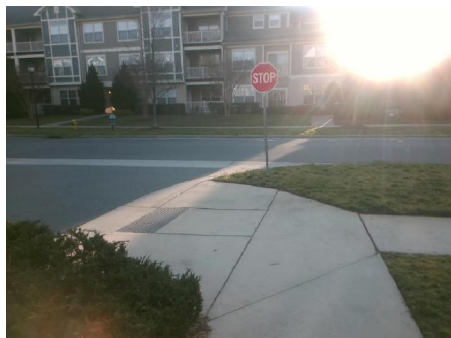
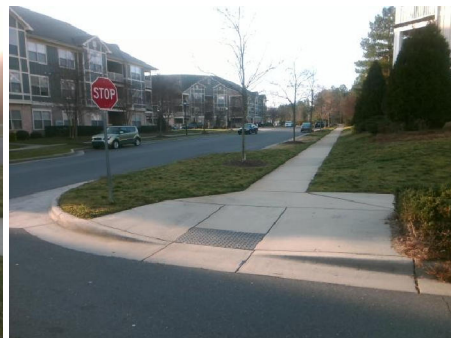
Possible Solutions:		Compliance	Description	Data	Compliance	Description	Data
	Remove & Replace Entire Ramp.		N/A	Ramp Length (in)	78.0	No	Ramp Slope (%)	9.3
			Yes	Ramp Width (in)	48.0	No	Ramp XSlope (%)	3.8
			N/A	Flare Type LT	N/A	N/A	Flare Type RT	N/A
			N/A	Flare Slope LT (%)	N/A	N/A	Flare Slope RT (%)	N/A
			N/A	Flare Traversable LT?	N/A	N/A	Flare Traversable RT?	N/A
			N/A	Landing Length (in)	N/A	N/A	DWS Provided?	N/A
			N/A	Landing Width (in)	N/A	N/A	DWS Contrast?	N/A
			N/A	Landing Slope (%)	N/A	N/A	DWS Length (in)	N/A
			N/A	Landing X Slope (%)	N/A	N/A	DWS Full Width?	N/A
Surveyor Notes:			N/A	Landing Curb? (Y/N)	N/A	N/A	DWS Offset (in)	N/A
PROW/ADA:				Shared Landing?	N/A			
R304.2.2, R304.5.3				Gutter Ponding?	N/A	N/A	Gutter Slope (%)	N/A
				Gutter Lip Ht (in)	N/A	N/A	Gutter X Slope (%)	N/A
				Painted X Walk1?	No	N/A	Painted X Walk2?	N/A

X Walk 1 Direction	To N		X Walk 2 Direction	N/A
			N/A	X Walk 1 Width (in)	N/A	N/A	X Walk 2 Width (in)	N/A
				X Walk 1 Slope (%)	0.0		X Walk 2 Slope (%)	N/A
				X Walk 1 X Slope (%)	2.1		X Walk 2 X Slope (%)	N/A
			N/A	Ramp inside XWalk1?	N/A	N/A	Ramp inside XWalk2?	N/A
				Road Slope (%)	N/A	N/A	Clear Space?	N/A
				Road X Slope (%)	N/A	N/A	Clear Space to XWalk (in)	N/A
			N/A	Any Obstructions?	N/A	N/A	Storm Grate/Utility Hazard?	N/A
				Obstruction Type			Storm Grate/Utility Type	
					N/A			N/A
						Yes	Surface Condition? (G/P)	Good
Street 1 Name		FALLON FARM RD						
Stop Condition-Street 2		StopSign						
Street 2 Name		N/A						
Stop Condition-Street 1		N/A						
Total Cost:		\$ 1850.00
