# Access Compliance Report

## Public Rights-of-Way

### (Curb Ramps)

Intersection ID: 30448	Main Street: NANNYBERRY_LN	Cross Street: WALLAND_LN	Location: SW
ADA ID: 8C66A3EBC77E	Ramp Type: PerpDiag	Initial Pass/Fail: Fail	Overall Compliance: No
Severity Score: 21.25			
Codes/Mitigation Info/Possible Solution		Field Measurements/Component Compliance

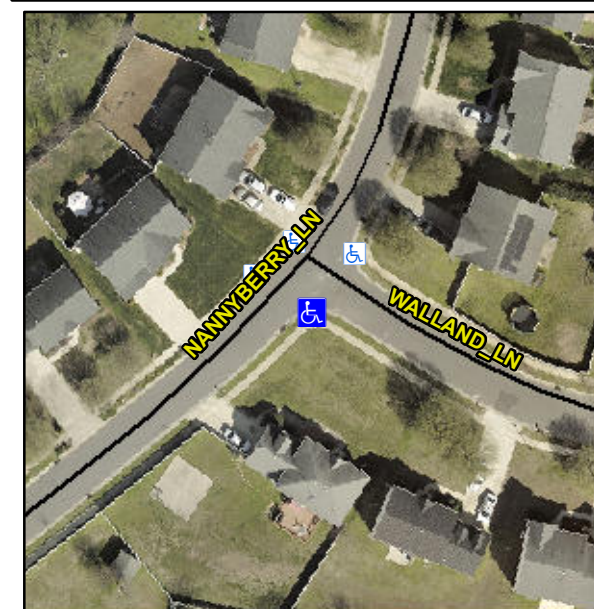
Compliance	Description	Data	Compliance	Description	Data
N/A	Ramp Length (in)	47.0	Yes	Ramp Slope (%)	5.2
No	Ramp Width (in)	45.0	No	Ramp XSlope (%)	5.7
N/A	Flare Type LT	N/A	N/A	Flare Type RT	N/A
N/A	Flare Slope LT (%)	N/A	N/A	Flare Slope RT (%)	N/A
N/A	Flare Traversable LT?	N/A	N/A	Flare Traversable RT?	N/A
N/A	Landing Length (in)	N/A	N/A	DWS Provided?	N/A
N/A	Landing Width (in)	N/A	N/A	DWS Contrast?	N/A
N/A	Landing Slope (%)	N/A	N/A	DWS Length (in)	N/A
N/A	Landing X Slope (%)	N/A	N/A	DWS Full Width?	N/A
N/A	Landing Curb? (Y/N)	N/A	N/A	DWS Offset (in)	N/A
N/A	Shared Landing?	N/A			
N/A	Gutter Ponding?	N/A	N/A	Gutter Slope (%)	N/A
N/A	Gutter Lip Ht (in)	N/A	N/A	Gutter X Slope (%)	N/A
N/A	Painted X Walk1?	No	N/A	Painted X Walk2?	No
	X Walk 1 Direction	To NE		X Walk 2 Direction	To NW
N/A	X Walk 1 Width (in)	N/A	N/A	X Walk 2 Width (in)	N/A
	X Walk 1 Slope (%)	0.4		X Walk 2 Slope (%)	0.7
	X Walk 1 X Slope (%)	4.0		X Walk 2 X Slope (%)	1.6

N/A	Ramp inside XWalk1?	N/A	N/A	Ramp inside XWalk2?	N/A
	Road Slope (%)	0.3	N/A	Clear Space?	N/A
	Road X Slope (%)	1.8	N/A	Clear Space to XWalk (in)	N/A
N/A	Any Obstructions?	N/A	N/A	Storm Grate/Utility Hazard?	N/A
	Obstruction Type			Storm Grate/Utility Type	
		N/A			N/A
		Yes		Surface Condition? (G/P)	Good

**Remove & Replace Curb Ramp With Two New Directional Ramps or Equivalent.**

**R304.5.1, R304.5.3**
