Access Compliance Report

Public Rights-of-Way (Curb Ramps)

Intersection ID: 10041074	Main Street: WATER RIDGE PY	Cross Street: N/A	Location: SW
ADA ID: 8C6A96D1439D	Ramp Type: PerpDiag	Initial Pass/Fail: Fail	Overall Compliance: No Severity Score: 46.25

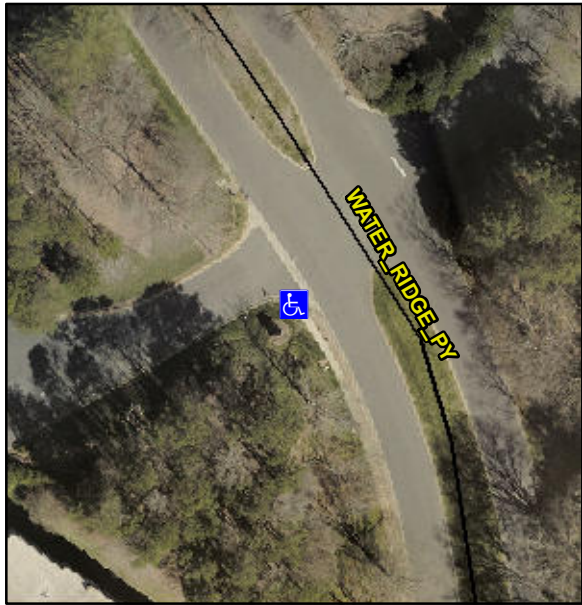
Possible Solutions:						
	Remove & Replace Curb Ramp With Two New Directional Ramps or Equivalent.	N/A	Ramp Length (in)	39.0	No	Ramp Slope (%)	10.4
		No	Ramp Width (in)	38.0	No	Ramp XSlope (%)	8.4
		N/A	Flare Type LT	N/A	N/A	Flare Type RT	N/A
		N/A	Flare Slope LT (%)	N/A	N/A	Flare Slope RT (%)	N/A
		N/A	Flare Traversable LT?	N/A	N/A	Flare Traversable RT?	N/A
		N/A	Landing Length (in)	N/A	N/A	DWS Provided?	N/A
		N/A	Landing Width (in)	N/A	N/A	DWS Contrast?	N/A
		N/A	Landing Slope (%)	N/A	N/A	DWS Length (in)	N/A
		N/A	Landing X Slope (%)	N/A	N/A	DWS Full Width?	N/A
Surveyor Notes:	N/A	N/A	Landing Curb? (Y/N)	N/A	N/A	DWS Offset (in)	N/A
		N/A	Shared Landing?	N/A			
		N/A	Gutter Ponding?	N/A	N/A	Gutter Slope (%)	N/A
		N/A	Gutter Lip Ht (in)	N/A	N/A	Gutter X Slope (%)	N/A
		N/A	Painted X Walk1?	No	N/A	Painted X Walk2?	No

X Walk 1 Direction	To E		X Walk 2 Direction	To N
		N/A	X Walk 1 Width (in)	N/A	N/A	X Walk 2 Width (in)	N/A
			X Walk 1 Slope (%)	2.7		X Walk 2 Slope (%)	8.4
			X Walk 1 X Slope (%)	4.0		X Walk 2 X Slope (%)	4.8
		N/A	Ramp inside XWalk1?	N/A	N/A	Ramp inside XWalk2?	N/A
PROW/ADA:	Not Found, R304.5.1, R304.2.2, R304.5.3		Road Slope (%)	6.2	N/A	Clear Space?	N/A
			Road X Slope (%)	2.1	N/A	Clear Space to XWalk (in)	N/A
		N/A	Any Obstructions?	N/A	N/A	Storm Grate/Utility Hazard?	N/A
			Obstruction Type			Storm Grate/Utility Type	
					N/A		N/A
					Yes	Surface Condition? (G/P)	Good
	Total Cost:		\$	3200.00			
	Street 1 Name		WATER RIDGE PY				
	Stop Condition-Street 2		None				
	Street 2 Name		ENTRANCE				
Stop Condition-Street 1		StopSign
