Intersection ID: 21853	Main Street: CHAMPAIGN_ST	Cross Street: HINSDALE_ST	Location:	SE
ADA ID: 8C77EBC937C4	Ramp Type: PerpDiag	Initial Pass/Fail: Fail	Overall Compliance: No	Severity Score: 50

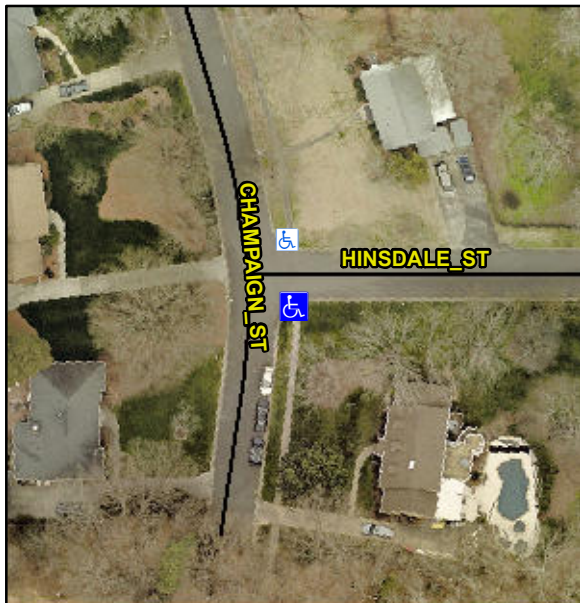
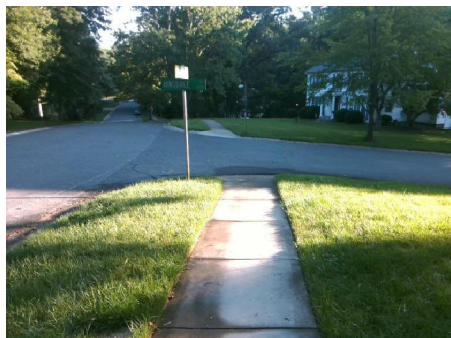
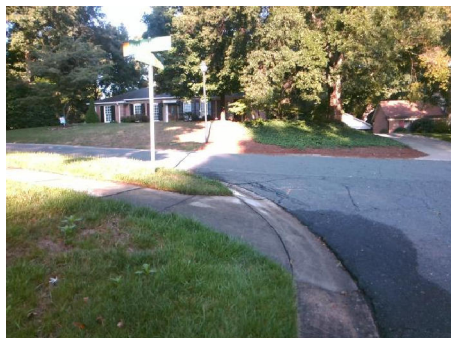
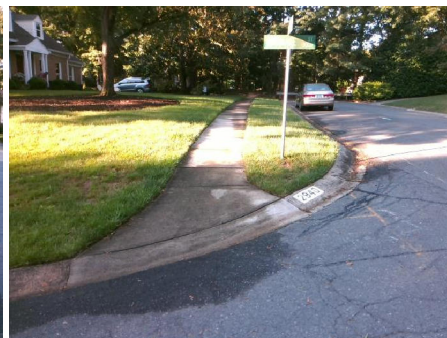
Possible Solutions:			Compliance	Description	Data	Compliance	Description	Data
	Remove & Replace Curb Ramp With Two New Directional Ramps or Equivalent.			N/A	Ramp Length (in)	300.0	Yes	Ramp Slope (%)	17.9
				Yes	Ramp Width (in)	48.0	No	Ramp XSlope (%)	13.6
				N/A	Flare Type LT	N/A	N/A	Flare Type RT	N/A
				N/A	Flare Slope LT (%)	N/A	N/A	Flare Slope RT (%)	N/A
				N/A	Flare Traversable LT?	N/A	N/A	Flare Traversable RT?	N/A
				N/A	Landing Length (in)	N/A	N/A	DWS Provided?	N/A
				N/A	Landing Width (in)	N/A	N/A	DWS Contrast?	N/A
				N/A	Landing Slope (%)	N/A	N/A	DWS Length (in)	N/A
				N/A	Landing X Slope (%)	N/A	N/A	DWS Full Width?	N/A
Street 1 Name	Surveyor Notes:			N/A	Landing Curb? (Y/N)	N/A	N/A	DWS Offset (in)	N/A
	N/A			N/A	Shared Landing?	N/A			
	PROW/ADA:			N/A	Gutter Ponding?	N/A	N/A	Gutter Slope (%)	N/A

Not Found, R304.5.3			N/A	Gutter Lip Ht (in)	N/A	N/A	Gutter X Slope (%)	N/A
				N/A	Painted X Walk1?	No	N/A	Painted X Walk2?	No
					X Walk 1 Direction	To N		X Walk 2 Direction	To W
				N/A	X Walk 1 Width (in)	N/A	N/A	X Walk 2 Width (in)	N/A
					X Walk 1 Slope (%)	0.9		X Walk 2 Slope (%)	10.3
					X Walk 1 X Slope (%)	8.6		X Walk 2 X Slope (%)	2.6
				N/A	Ramp inside XWalk1?	N/A	N/A	Ramp inside XWalk2?	N/A
				Road Slope (%)	8.7	N/A	Clear Space?	N/A	
				Road X Slope (%)	4.3	N/A	Clear Space to XWalk (in)	N/A	
			N/A	Any Obstructions?	N/A	N/A	Storm Grate/Utility Hazard?	N/A	
				Obstruction Type			Storm Grate/Utility Type		
					N/A			N/A	
						Yes	Surface Condition? (G/P)	Good	
Street 1 Name		HINSDALE ST							
Stop Condition-Street 2		StopSign							
Street 2 Name		CHAMPAIGN ST							
Stop Condition-Street 1		None							
Total Cost:		\$ 3200.00
