Access Compliance Report Public Rights-of-Way (Curb Ramps)

Intersection ID: 28073	Main Street: ARDREY_KELL_RD	Cross Street: LANDEN_DR	Location: N
ADA ID: 8C896B387844	Ramp Type: PerpDiag	Initial Pass/Fail: Fail	Overall Compliance: No Severity Score: 33.75

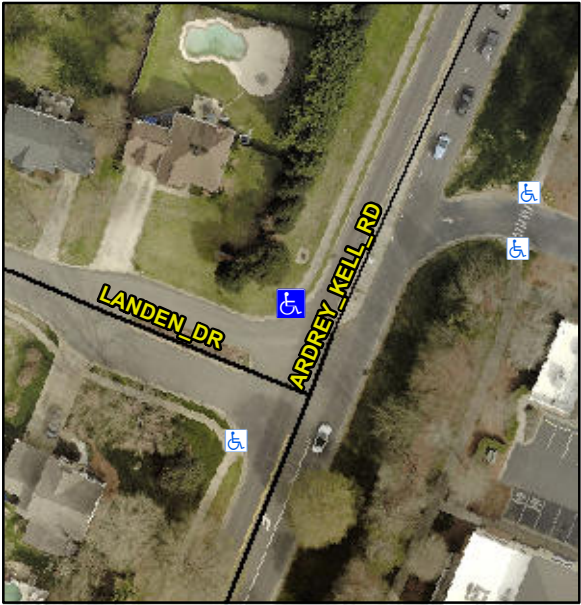
PROW/ADA:
Not Found, R304.5.1, R304.5.3

Compliance	Description	Data	Compliance	Description	Data
N/A	Ramp Length (in)	89.0	Yes	Ramp Slope (%)	6.9
No	Ramp Width (in)	41.0	No	Ramp XSlope (%)	7.4
N/A	Flare Type LT	N/A	N/A	Flare Type RT	N/A
N/A	Flare Slope LT (%)	N/A	N/A	Flare Slope RT (%)	N/A
N/A	Flare Traversable LT?	N/A	N/A	Flare Traversable RT?	N/A
N/A	Landing Length (in)	N/A	N/A	DWS Provided?	N/A
N/A	Landing Width (in)	N/A	N/A	DWS Contrast?	N/A
N/A	Landing Slope (%)	N/A	N/A	DWS Length (in)	N/A
N/A	Landing X Slope (%)	N/A	N/A	DWS Full Width?	N/A
N/A	Landing Curb? (Y/N)	N/A	N/A	DWS Offset (in)	N/A
N/A	Shared Landing?	N/A			
N/A	Gutter Ponding?	N/A	N/A	Gutter Slope (%)	N/A
N/A	Gutter Lip Ht (in)	N/A	N/A	Gutter X Slope (%)	N/A
N/A	Painted X Walk1?	No	N/A	Painted X Walk2?	No
	X Walk 1 Direction	To SW		X Walk 2 Direction	To SE
N/A	X Walk 1 Width (in)	N/A	N/A	X Walk 2 Width (in)	N/A
	X Walk 1 Slope (%)	1.5		X Walk 2 Slope (%)	6.1
	X Walk 1 X Slope (%)	5.6		X Walk 2 X Slope (%)	1.8

N/A	Ramp inside XWalk1?	N/A	N/A	Ramp inside XWalk2?	N/A
	Road Slope (%)	4.5	N/A	Clear Space?	N/A
	Road X Slope (%)	4.5	N/A	Clear Space to XWalk (in)	N/A
N/A	Any Obstructions?	N/A	N/A	Storm Grate/Utility Hazard?	N/A
	Obstruction Type			Storm Grate/Utility Type	
		N/A			N/A
			Yes	Surface Condition? (G/P)	Good

Possible Solutions:
Remove & Replace Curb Ramp With Two New Directional Ramps or Equivalent.

Total Cost: \$ **3200.00**
