Access Compliance Report

Public Rights-of-Way

(Curb Ramps)

Intersection ID: 27895	Main Street: FAIR_ISLE_DR	Cross Street: KILCHURN_CT	Location: SW
ADA ID: 8CA608C0839D	Ramp Type: PerpDiag	Initial Pass/Fail: Fail	Overall Compliance: No
			Severity Score: 72.5
Codes/Mitigation Info/Possible Solution		Field Measurements/Component Compliance

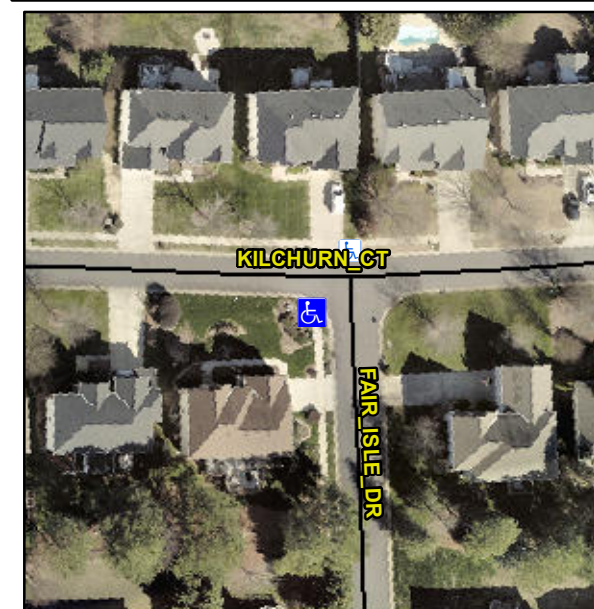
Not Found, R304.5.1, R304.2.2, R304.5.3

Compliance	Description	Data	Compliance	Description	Data
N/A	Ramp Length (in)	96.0	No	Ramp Slope (%)	8.4
No	Ramp Width (in)	25.0	No	Ramp XSlope (%)	8.7
N/A	Flare Type LT	N/A	N/A	Flare Type RT	N/A
N/A	Flare Slope LT (%)	N/A	N/A	Flare Slope RT (%)	N/A
N/A	Flare Traversable LT?	N/A	N/A	Flare Traversable RT?	N/A
N/A	Landing Length (in)	N/A	N/A	DWS Provided?	N/A
N/A	Landing Width (in)	N/A	N/A	DWS Contrast?	N/A
N/A	Landing Slope (%)	N/A	N/A	DWS Length (in)	N/A
N/A	Landing X Slope (%)	N/A	N/A	DWS Full Width?	N/A
N/A	Landing Curb? (Y/N)	N/A	N/A	DWS Offset (in)	N/A
N/A	Shared Landing?	N/A			
N/A	Gutter Ponding?	N/A	N/A	Gutter Slope (%)	N/A
N/A	Gutter Lip Ht (in)	N/A	N/A	Gutter X Slope (%)	N/A
N/A	Painted X Walk1?	No	N/A	Painted X Walk2?	No
	X Walk 1 Direction	To SE		X Walk 2 Direction	To NE
N/A	X Walk 1 Width (in)	N/A	N/A	X Walk 2 Width (in)	N/A
	X Walk 1 Slope (%)	1.3		X Walk 2 Slope (%)	1.1
	X Walk 1 X Slope (%)	2.7		X Walk 2 X Slope (%)	3.8

N/A	Ramp inside XWalk1?	N/A	N/A	Ramp inside XWalk2?	N/A
	Road Slope (%)	4.8	N/A	Clear Space?	N/A
	Road X Slope (%)	1.3	N/A	Clear Space to XWalk (in)	N/A
N/A	Any Obstructions?	N/A	N/A	Storm Grate/Utility Hazard?	N/A
	Obstruction Type			Storm Grate/Utility Type	
		N/A			N/A
			Yes	Surface Condition? (G/P)	Good

Remove & Replace Curb Ramp With Two New Directional Ramps or Equivalent.
