Access Compliance Report

Public Rights-of-Way

(Curb Ramps)

| ADA ID: 8CA63E67768B | Ramp Type: BlendTrans2 | Initial Pass/Fail: Pass | Overall Compliance: No | Severity Score: 0.25 |

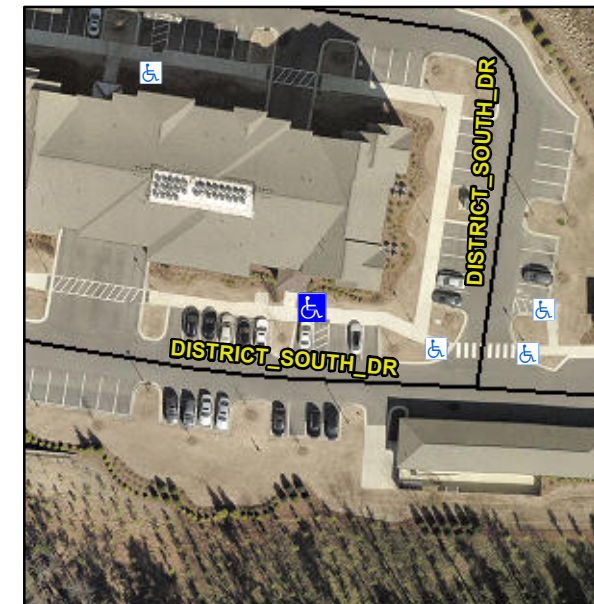
R304.5.3

| Compliance | Description | Data | Compliance | Description | Data |
|---|---|---|---|---|---|
| Yes | Ramp Width (in) | 96.0 | No | BlendTrans XSlope (%) | 2.7 |

Remove & Replace Curb Ramp With Two New Directional Ramps or Equivalent.

\$ 3200.00
