Access Compliance Report

Public Rights-of-Way

(Curb Ramps)

Intersection ID: 14828	Main Street: DWIGHTWARE_BV	Cross Street: SHACKLEFORD_TR	Location: SW
ADA ID: 8CA8F32CE9FE	Ramp Type: Perp	Initial Pass/Fail: Fail	Overall Compliance: No
Codes/Mitigation Info/Possible Solution		Field Measurements/Component Compliance	
Severity Score: 13.75

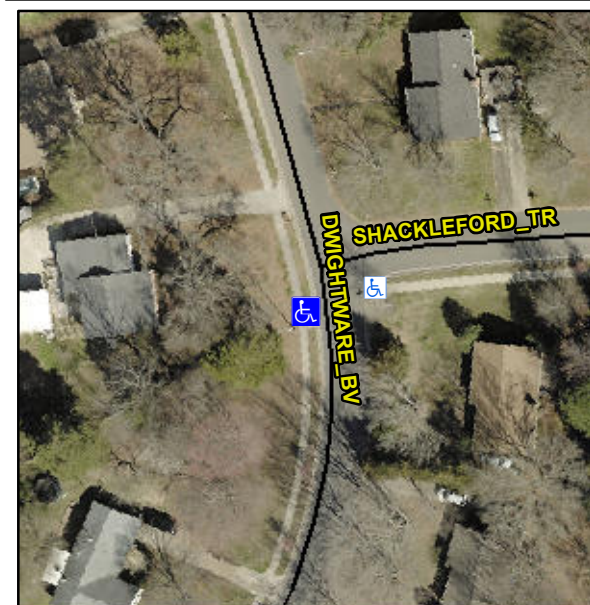
Not Found, R304.2.2, R304.5.3

Compliance	Description	Data	Compliance	Description	Data
N/A	Ramp Length (in)	49.0	No	Ramp Slope (%)	8.7
Yes	Ramp Width (in)	48.0	No	Ramp XSlope (%)	3.4
N/A	Flare Type LT	N/A	N/A	Flare Type RT	N/A
N/A	Flare Slope LT (%)	N/A	N/A	Flare Slope RT (%)	N/A
N/A	Flare Traversable LT?	N/A	N/A	Flare Traversable RT?	N/A
N/A	Landing Length (in)	N/A	N/A	DWS Provided?	N/A
N/A	Landing Width (in)	N/A	N/A	DWS Contrast?	N/A
N/A	Landing Slope (%)	N/A	N/A	DWS Length (in)	N/A
N/A	Landing X Slope (%)	N/A	N/A	DWS Full Width?	N/A
N/A	Landing Curb? (Y/N)	N/A	N/A	DWS Offset (in)	N/A
N/A	Shared Landing?	N/A			
N/A	Gutter Ponding?	N/A	N/A	Gutter Slope (%)	N/A
N/A	Gutter Lip Ht (in)	N/A	N/A	Gutter X Slope (%)	N/A
N/A	Painted X Walk1?	No	N/A	Painted X Walk2?	N/A
	X Walk 1 Direction	To E		X Walk 2 Direction	N/A
N/A	X Walk 1 Width (in)	N/A	N/A	X Walk 2 Width (in)	N/A
	X Walk 1 Slope (%)	3.7		X Walk 2 Slope (%)	N/A
	X Walk 1 X Slope (%)	1.7		X Walk 2 X Slope (%)	N/A

N/A	Ramp inside XWalk1?	N/A	N/A	Ramp inside XWalk2?	N/A
	Road Slope (%)	N/A	N/A	Clear Space?	N/A
	Road X Slope (%)	N/A	N/A	Clear Space to XWalk (in)	N/A
N/A	Any Obstructions?	N/A	N/A	Storm Grate/Utility Hazard?	N/A
	Obstruction Type			Storm Grate/Utility Type	
		N/A			N/A
			Yes	Surface Condition? (G/P)	Good

Possible Solutions:

Remove & Replace Entire Ramp.
