Access Compliance Report

Public Rights-of-Way (Curb Ramps)

Intersection ID: 2903	Main Street: FOGGY_MEADOW_RD	Cross Street: RED_CLOVER_LN	Location:	SW
ADA ID: 8CC4CC5A6404	Ramp Type: Perp	Initial Pass/Fail: Pass	Overall Compliance: No	Severity Score: 7.5

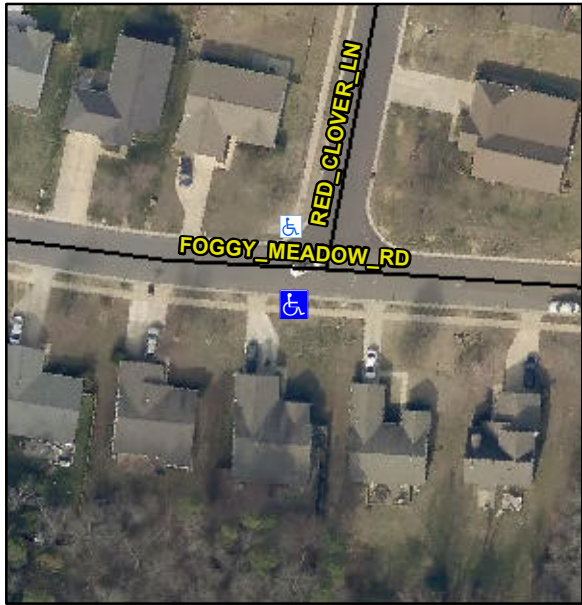
Possible Solutions:		Compliance	Description	Data	Compliance	Description	Data
	Remove & Replace Gutter.		N/A	Ramp Length (in)	47.0	Yes	Ramp Slope (%)	7.2
			Yes	Ramp Width (in)	60.0	Yes	Ramp XSlope (%)	1.3
			N/A	Flare Type LT	Sloped	N/A	Flare Type RT	N/A
			N/A	Flare Slope LT (%)	0.7	N/A	Flare Slope RT (%)	7.2
			N/A	Flare Traversable LT?	No	N/A	Flare Traversable RT?	No
			Yes	Landing Length (in)	48.0	Yes	DWS Provided?	Yes
			Yes	Landing Width (in)	48.0	Yes	DWS Contrast?	Yes
			Yes	Landing Slope (%)	0.2	Yes	DWS Length (in)	24.0
			Yes	Landing X Slope (%)	1.5	Yes	DWS Full Width?	Yes
Surveyor Notes:		N/A	N/A	Landing Curb? (Y/N)	No	Yes	DWS Offset (in)	1.0
PROW/ADA:		R302.7.2, R304.5.3	N/A	Shared Landing?	No			
			Yes	Gutter Ponding?	No	Yes	Gutter Slope (%)	4.6
			No	Gutter Lip Ht (in)	0.5	No	Gutter X Slope (%)	3.4
			N/A	Painted X Walk1?	No	N/A	Painted X Walk2?	N/A

X Walk 1 Direction	To N		X Walk 2 Direction	N/A
			N/A	X Walk 1 Width (in)	N/A	N/A	X Walk 2 Width (in)	N/A
				X Walk 1 Slope (%)	6.7		X Walk 2 Slope (%)	N/A
				X Walk 1 X Slope (%)	2.7		X Walk 2 X Slope (%)	N/A
			N/A	Ramp inside XWalk1?	N/A	N/A	Ramp inside XWalk2?	N/A
				Road Slope (%)	N/A	N/A	Clear Space?	Yes
				Road X Slope (%)	N/A	N/A	Clear Space to XWalk (in)	N/A
			Yes	Any Obstructions?	No	Yes	Storm Grate/Utility Hazard?	No
				Obstruction Type			Storm Grate/Utility Type	
						N/A		N/A
						Yes	Surface Condition? (G/P)	Good
