Access Compliance Report

Public Rights-of-Way

(Curb Ramps)

Intersection ID: 43601	Main Street: BALLANTYNE_COMMONS_PY	Cross Street: COSTIGAN_LN	Location: SE
ADA ID: 8CC687C3B89D	Ramp Type: Perp	Initial Pass/Fail: Fail	Overall Compliance: No
		Severity Score: 1.25	
Codes/Mitigation Info/Possible Solution		Field Measurements/Component Compliance

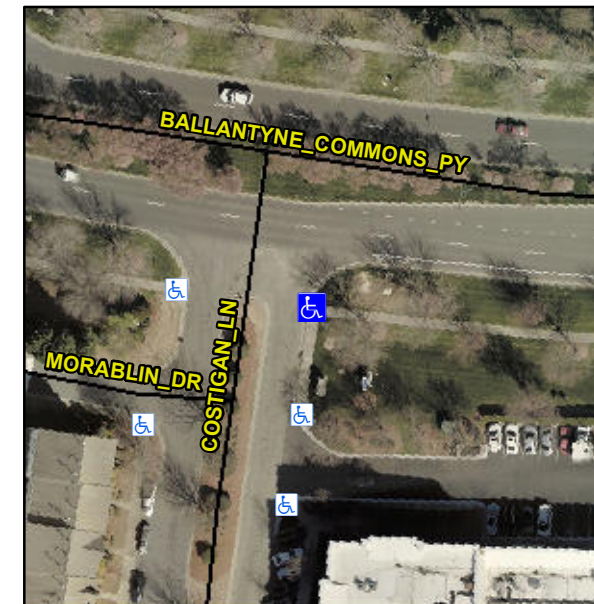
Not Found, R304.5.3

Compliance	Description	Data	Compliance	Description	Data
N/A	Ramp Length (in)	94.0	Yes	Ramp Slope (%)	7.3
Yes	Ramp Width (in)	61.0	No	Ramp XSlope (%)	2.4
N/A	Flare Type LT	N/A	N/A	Flare Type RT	N/A
N/A	Flare Slope LT (%)	N/A	N/A	Flare Slope RT (%)	N/A
N/A	Flare Traversable LT?	N/A	N/A	Flare Traversable RT?	N/A
N/A	Landing Length (in)	N/A	N/A	DWS Provided?	N/A
N/A	Landing Width (in)	N/A	N/A	DWS Contrast?	N/A
N/A	Landing Slope (%)	N/A	N/A	DWS Length (in)	N/A
N/A	Landing X Slope (%)	N/A	N/A	DWS Full Width?	N/A
N/A	Landing Curb? (Y/N)	N/A	N/A	DWS Offset (in)	N/A
N/A	Shared Landing?	N/A			
N/A	Gutter Ponding?	N/A	N/A	Gutter Slope (%)	N/A
N/A	Gutter Lip Ht (in)	N/A	N/A	Gutter X Slope (%)	N/A
N/A	Painted X Walk1?	No	N/A	Painted X Walk2?	N/A
	X Walk 1 Direction	To NW		X Walk 2 Direction	N/A
N/A	X Walk 1 Width (in)	N/A	N/A	X Walk 2 Width (in)	N/A
	X Walk 1 Slope (%)	2.3		X Walk 2 Slope (%)	N/A
	X Walk 1 X Slope (%)	2.9		X Walk 2 X Slope (%)	N/A

N/A	Ramp inside XWalk1?	N/A	N/A	Ramp inside XWalk2?	N/A
	Road Slope (%)	N/A	N/A	Clear Space?	N/A
	Road X Slope (%)	N/A	N/A	Clear Space to XWalk (in)	N/A
N/A	Any Obstructions?	N/A	N/A	Storm Grate/Utility Hazard?	N/A
	Obstruction Type			Storm Grate/Utility Type	
		N/A			N/A
			Yes	Surface Condition? (G/P)	Good

Remove & Replace Entire Ramp.

Total Cost: \$ 1850.00
