# Access Compliance Report

## Public Rights-of-Way

### (Curb Ramps)

| Intersection ID: 44690 | Main Street: SMOOTH_PATH_DR | Cross Street: HARWOOD_HILLS_LN | Location: SW |

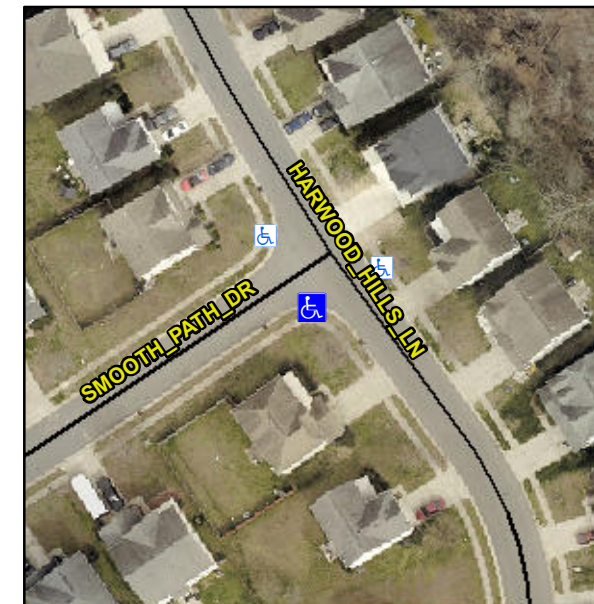
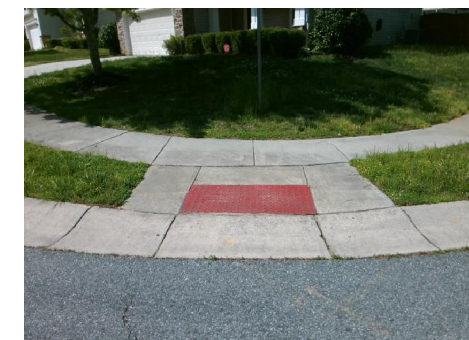
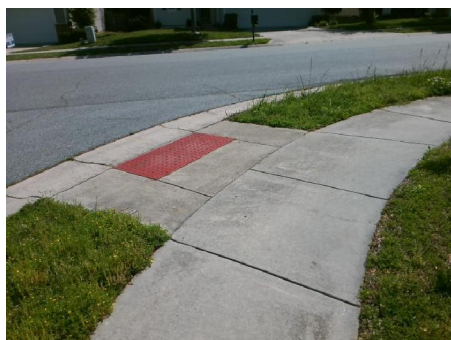
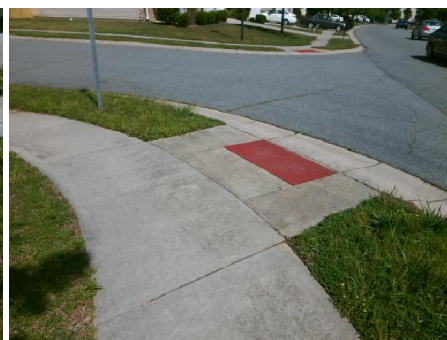
| ADA ID: 8CDA33E37C82 | Ramp Type: PerpDiag | Initial Pass/Fail: Fail | Overall Compliance: No |

| Severity Score: 8.75 | | | |

**Not Found, R304.5.1**

| Compliance | Description | Data | Compliance | Description | Data |
|---|---|---|---|---|---|
| No | Ramp Width (in) | 47.0 | Yes | Ramp XSlope (%) | 1.5 |

**Remove & Replace Curb Ramp With Two New Directional Ramps or Equivalent.**

Total Cost: \$ 3200.00
