Access Compliance Report

Public Rights-of-Way

(Curb Ramps)

Intersection ID: 44271	Main Street: BRITTNI_DAYLE_DR	Cross Street: TRAVIS_FLOYD_LN	Location: NW
ADA ID: 8CE15FC94A13	Ramp Type: PerpDiag	Initial Pass/Fail: Fail	Overall Compliance: No
Severity Score: 33.75			
Codes/Mitigation Info/Possible Solution		Field Measurements/Component Compliance

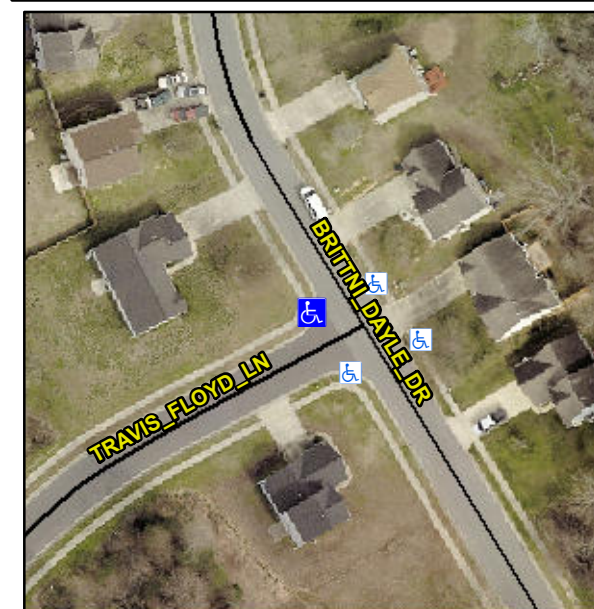
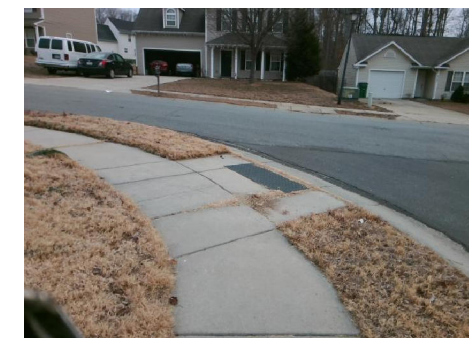
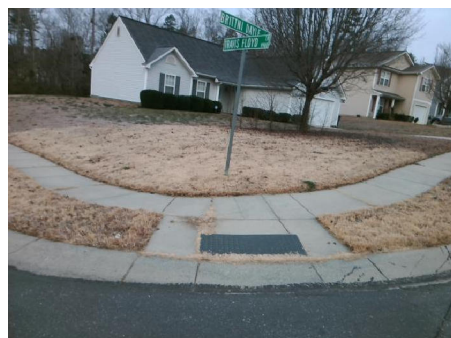
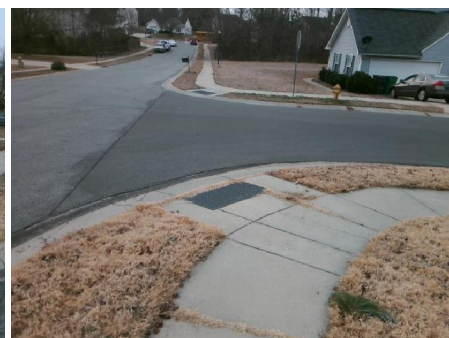
Not Found, R304.5.1, R304.5.3

Compliance	Description	Data	Compliance	Description	Data
N/A	Ramp Length (in)	47.0	Yes	Ramp Slope (%)	5.0
No	Ramp Width (in)	41.5	No	Ramp XSlope (%)	9.4
N/A	Flare Type LT	N/A	N/A	Flare Type RT	N/A
N/A	Flare Slope LT (%)	N/A	N/A	Flare Slope RT (%)	N/A
N/A	Flare Traversable LT?	N/A	N/A	Flare Traversable RT?	N/A
N/A	Landing Length (in)	N/A	N/A	DWS Provided?	N/A
N/A	Landing Width (in)	N/A	N/A	DWS Contrast?	N/A
N/A	Landing Slope (%)	N/A	N/A	DWS Length (in)	N/A
N/A	Landing X Slope (%)	N/A	N/A	DWS Full Width?	N/A
N/A	Landing Curb? (Y/N)	N/A	N/A	DWS Offset (in)	N/A
N/A	Shared Landing?	N/A			
N/A	Gutter Ponding?	N/A	N/A	Gutter Slope (%)	N/A
N/A	Gutter Lip Ht (in)	N/A	N/A	Gutter X Slope (%)	N/A
N/A	Painted X Walk1?	No	N/A	Painted X Walk2?	No
	X Walk 1 Direction	To S		X Walk 2 Direction	To E
N/A	X Walk 1 Width (in)	N/A	N/A	X Walk 2 Width (in)	N/A
	X Walk 1 Slope (%)	2.6		X Walk 2 Slope (%)	7.2
	X Walk 1 X Slope (%)	6.4		X Walk 2 X Slope (%)	4.7

N/A	Ramp inside XWalk1?	N/A	N/A	Ramp inside XWalk2?	N/A
	Road Slope (%)	8.6	N/A	Clear Space?	N/A
	Road X Slope (%)	1.3	N/A	Clear Space to XWalk (in)	N/A
N/A	Any Obstructions?	N/A	N/A	Storm Grate/Utility Hazard?	N/A
	Obstruction Type			Storm Grate/Utility Type	
		N/A			N/A
			Yes	Surface Condition? (G/P)	Good

Remove & Replace Curb Ramp With Two New Directional Ramps or Equivalent.
