Access Compliance Report

Public Rights-of-Way

(Curb Ramps)

Intersection ID: 17330	Main Street: FIRWOOD_LN	Cross Street: KENLOUGH_DR	Location: NE
ADA ID: 8CEB481DB6D2	Ramp Type: Directional1	Initial Pass/Fail: Fail	Overall Compliance: No
		Severity Score: 1.25

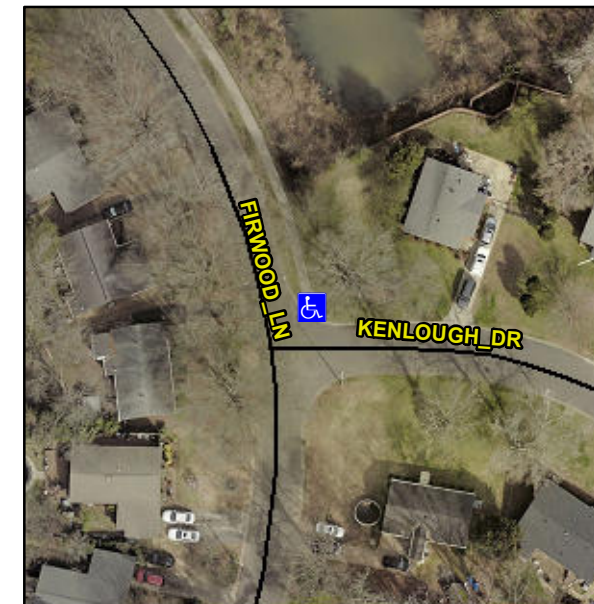
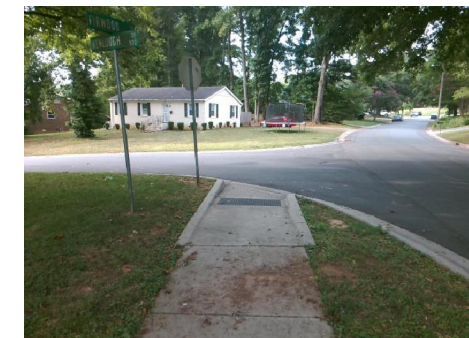
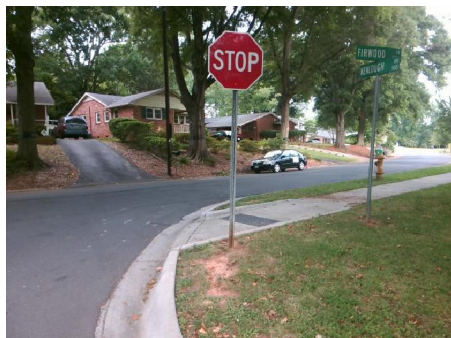
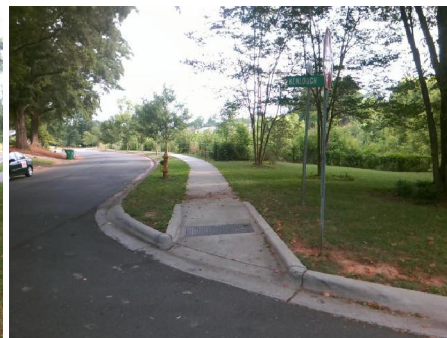
Compliance	Description	Data	Compliance	Description	Data
N/A	Ramp Length (in)	120.0	N/A	Grade Break?	N/A
Yes	Ramp Width (in)	58.0	N/A	Grade Break Slope (%)	0.0
Yes	Ramp Slope (%)	2.8	N/A	Grade Break XSlope (%)	0.0
No	Ramp XSlope (%)	2.1			
N/A	Flare Type LT	N/A	N/A	Flare Type RT	N/A
N/A	Flare Slope LT (%)	N/A	N/A	Flare Slope RT (%)	0.0
N/A	Flare Traversable LT?	N/A	N/A	Flare Traversable RT?	N/A
N/A	Landing Length (in)	0.0	N/A	DWS Provided?	N/A
N/A	Landing Width (in)	0.0	N/A	DWS Contrast?	N/A
N/A	Landing Slope (%)	0.0	N/A	DWS Length (in)	N/A
N/A	Landing X Slope (%)	0.0	N/A	DWS Full Width?	N/A
N/A	Landing Curb? (Y/N)	N/A	N/A	DWS Offset LT (in)	N/A
N/A	Shared Landing?	N/A	N/A	DWS Offset RT (in)	N/A
N/A	Gutter Ponding?	0.0	N/A	Gutter Slope (%)	N/A
N/A	Gutter Lip Ht (in)	0.0	N/A	Gutter X Slope (%)	N/A
N/A	Painted X Walk1?	No		Road Slope (%)	2.0
	X Walk 1 Direction	To SE		Road X Slope (%)	3.7
	X Walk 1 Width (in)	N/A		Clear Space?	N/A

X Walk 1 Slope (%)	2.0	N/A	Clear Space to XWalk (in)	N/A
	X Walk 1 X Slope (%)	3.7	N/A	Storm Grate/Utility Hazard?	N/A
N/A	Ramp inside XWalk1?	N/A		Storm Grate/Utility Type	
N/A	Any Obstructions?	N/A			N/A
	Obstruction Type		Yes	Surface Condition? (G/P)	Good
			N/A	Curb Slope (%)	13.6

Remove & Replace Entire Ramp.
