Access Compliance Report Public Rights-of-Way (Curb Ramps)

Intersection ID: 19216 Main Street: RAMA_RD Cross Street: SARDIS_RD Location: SW **Overall Compliance: No ADA ID: 8CEECC1FCD60** Ramp Type: Perp Initial Pass/Fail: Fail **Severity Score:** 12.5

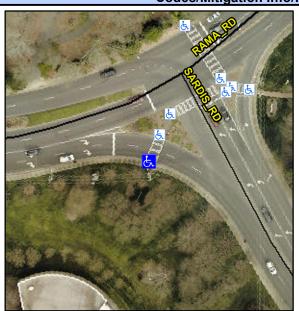
Field Measurements/Component Compliance								
Compl	iance Description	Data	Compl	iance	Description	Data		
N/A	Ramp Length (in)	60.0	No	Ramp	Slope (%)	8.4		
Yes	Ramp Width (in)	48.0	Yes	Ramp	XSlope (%)	0.2		
N/A	Flare Type LT	N/A	N/A	Flare	Type RT	N/A		
N/A	Flare Slope LT (%)	N/A	N/A	Flare	Slope RT (%)	N/A		
N/A	Flare Traversable LT?	N/A	N/A	Flare	Traversable RT?	N/A		
N/A	Landing Length (in)	N/A	N/A	DWS	Provided?	N/A		
N/A	Landing Width (in)	N/A	N/A	DWS	Contrast?	N/A		
N/A	Landing Slope (%)	N/A	N/A	DWS	Length (in)	N/A		
N/A	Landing X Slope (%)	N/A	N/A	DWS	Full Width?	N/A		
N/A	Landing Curb? (Y/N)	N/A	N/A	DWS	Offset (in)	N/A		
N/A	Shared Landing?	N/A						
N/A	Gutter Ponding?	N/A	N/A	Gutte	r Slope (%)	N/A		
N/A	Gutter Lip Ht (in)	N/A	N/A	Gutte	r X Slope (%)	N/A		
N/A	Painted X Walk1?	Yes	N/A	Paint	ed X Walk2?	N/A		
	X Walk 1 Direction	To NE		X Wa	lk 2 Direction	N/A		
N/A	X Walk 1 Width (in)	113.0	N/A	X Wa	lk 2 Width (in)	N/A

OSSIBIE SOIGHOIT	
Possible Solutions:	Co
Remove & Replace Entire Ramp.	N/A
·	Yes
	N/A
	N/A
	N/A
	N/A
Surveyor Notes:	N/A
N/A	N/A
	N/A
	N/A
	N/A
PROW/ADA:	N/A
Not Found, R304.2.2	N/A
	N/A
	N/A
	N/A
