Access Compliance Report

Public Rights-of-Way

(Curb Ramps)

Intersection ID: 7479	Main Street: COTTONWOOD_ST	Cross Street: JOE_ST	Location: S
ADA ID: 8CF0B055F674	Ramp Type: Perp	Initial Pass/Fail: Fail	Overall Compliance: No
Severity Score: 8.75			
Codes/Mitigation Info/Possible Solution		Field Measurements/Component Compliance

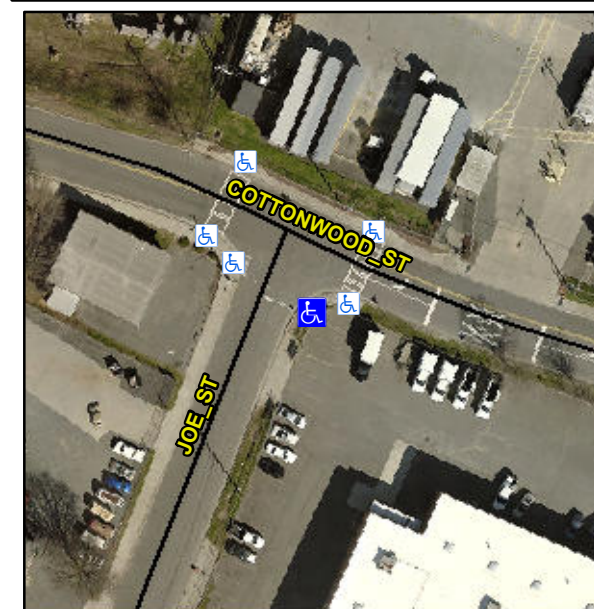
Not Found, R304.5.1

Compliance	Description	Data	Compliance	Description	Data
N/A	Ramp Length (in)	71.0	Yes	Ramp Slope (%)	8.3
No	Ramp Width (in)	47.5	Yes	Ramp XSlope (%)	1.1
N/A	Flare Type LT	N/A	N/A	Flare Type RT	N/A
N/A	Flare Slope LT (%)	N/A	N/A	Flare Slope RT (%)	N/A
N/A	Flare Traversable LT?	N/A	N/A	Flare Traversable RT?	N/A
N/A	Landing Length (in)	N/A	N/A	DWS Provided?	N/A
N/A	Landing Width (in)	N/A	N/A	DWS Contrast?	N/A
N/A	Landing Slope (%)	N/A	N/A	DWS Length (in)	N/A
N/A	Landing X Slope (%)	N/A	N/A	DWS Full Width?	N/A
N/A	Landing Curb? (Y/N)	N/A	N/A	DWS Offset (in)	N/A
N/A	Shared Landing?	N/A			
N/A	Gutter Ponding?	N/A	N/A	Gutter Slope (%)	N/A
N/A	Gutter Lip Ht (in)	0.5	N/A	Gutter X Slope (%)	N/A
N/A	Painted X Walk1?	Yes	N/A	Painted X Walk2?	N/A
	X Walk 1 Direction	To NW		X Walk 2 Direction	N/A
N/A	X Walk 1 Width (in)	111.0	N/A	X Walk 2 Width (in)	N/A
	X Walk 1 Slope (%)	5.0		X Walk 2 Slope (%)	N/A
	X Walk 1 X Slope (%)	7.9		X Walk 2 X Slope (%)	N/A

N/A	Ramp inside XWalk1?	Yes	N/A	Ramp inside XWalk2?	N/A
	Road Slope (%)	N/A	N/A	Clear Space?	N/A
	Road X Slope (%)	N/A	N/A	Clear Space to XWalk (in)	N/A
N/A	Any Obstructions?	N/A	N/A	Storm Grate/Utility Hazard?	N/A
	Obstruction Type			Storm Grate/Utility Type	
		N/A			N/A
		Yes		Surface Condition? (G/P)	Good

Possible Solutions:

Remove & Replace Entire Ramp.
