Access Compliance Report

Public Rights-of-Way

(Curb Ramps)

Intersection ID: 49398	Main Street: HEREFORD_ST	Cross Street: BARROSO_LN	Location: NE
ADA ID: 8CF1FAAD877E	Ramp Type: Perp	Initial Pass/Fail: Fail	Overall Compliance: No
		Severity Score: 8.75

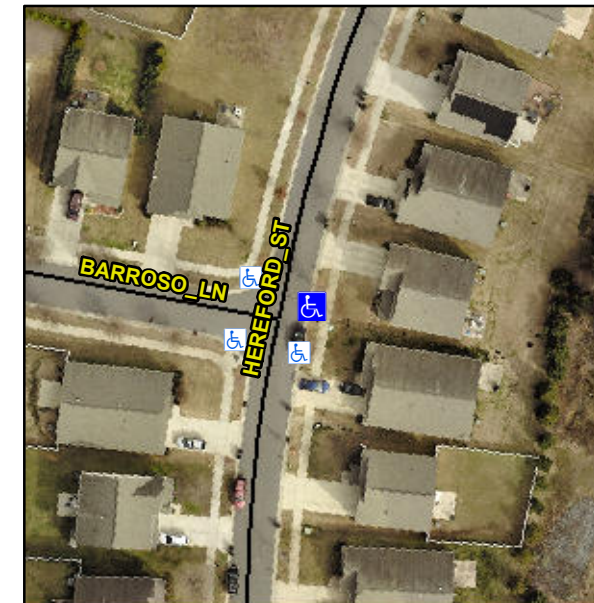
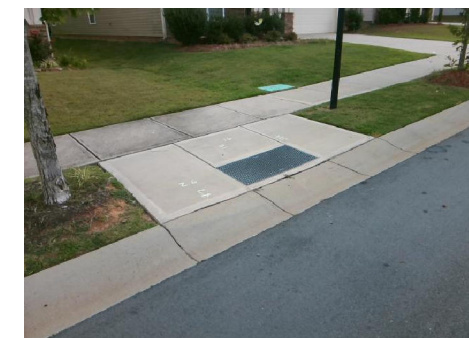
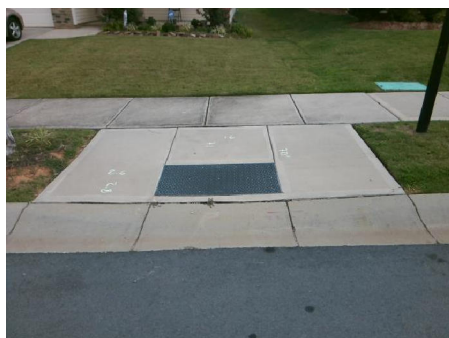
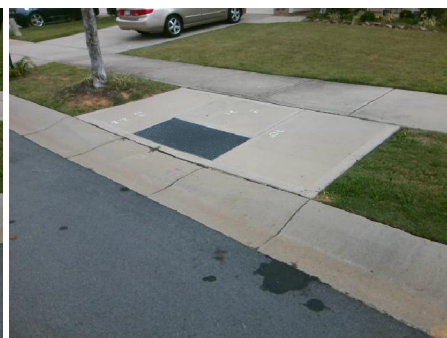
Compliance	Description	Data	Compliance	Description	Data
N/A	Ramp Length (in)	70.0	Yes	Ramp Slope (%)	7.1
No	Ramp Width (in)	47.0	Yes	Ramp XSlope (%)	1.6
N/A	Flare Type LT	N/A	N/A	Flare Type RT	N/A
N/A	Flare Slope LT (%)	N/A	N/A	Flare Slope RT (%)	N/A
N/A	Flare Traversable LT?	N/A	N/A	Flare Traversable RT?	N/A
N/A	Landing Length (in)	N/A	N/A	DWS Provided?	N/A
N/A	Landing Width (in)	N/A	N/A	DWS Contrast?	N/A
N/A	Landing Slope (%)	N/A	N/A	DWS Length (in)	N/A
N/A	Landing X Slope (%)	N/A	N/A	DWS Full Width?	N/A
N/A	Landing Curb? (Y/N)	N/A	N/A	DWS Offset (in)	N/A
N/A	Shared Landing?	N/A			
N/A	Gutter Ponding?	N/A	N/A	Gutter Slope (%)	N/A
N/A	Gutter Lip Ht (in)	N/A	N/A	Gutter X Slope (%)	N/A
N/A	Painted X Walk1?	No	N/A	Painted X Walk2?	N/A
	X Walk 1 Direction	To NW		X Walk 2 Direction	N/A
N/A	X Walk 1 Width (in)	N/A	N/A	X Walk 2 Width (in)	N/A
	X Walk 1 Slope (%)	2.8		X Walk 2 Slope (%)	N/A
	X Walk 1 X Slope (%)	2.6		X Walk 2 X Slope (%)	N/A

N/A	Ramp inside XWalk1?	N/A	N/A	Ramp inside XWalk2?	N/A
	Road Slope (%)	N/A	N/A	Clear Space?	N/A
	Road X Slope (%)	N/A	N/A	Clear Space to XWalk (in)	N/A
N/A	Any Obstructions?	N/A	N/A	Storm Grate/Utility Hazard?	N/A
	Obstruction Type			Storm Grate/Utility Type	
		N/A			N/A
			Yes	Surface Condition? (G/P)	Good

Possible Solutions:

Remove & Replace Entire Ramp.

Not Found, R304.5.1
