# Access Compliance Report

## Public Rights-of-Way

### (Curb Ramps)

Intersection ID: 5873	Main Street: BOMAR_DR	Cross Street: HAMILTON_CR	Location: SE
ADA ID: 8CF38D30E9E5	Ramp Type: Perp	Initial Pass/Fail: Fail	Overall Compliance: No
Severity Score: 36.25			
Codes/Mitigation Info/Possible Solution		Field Measurements/Component Compliance

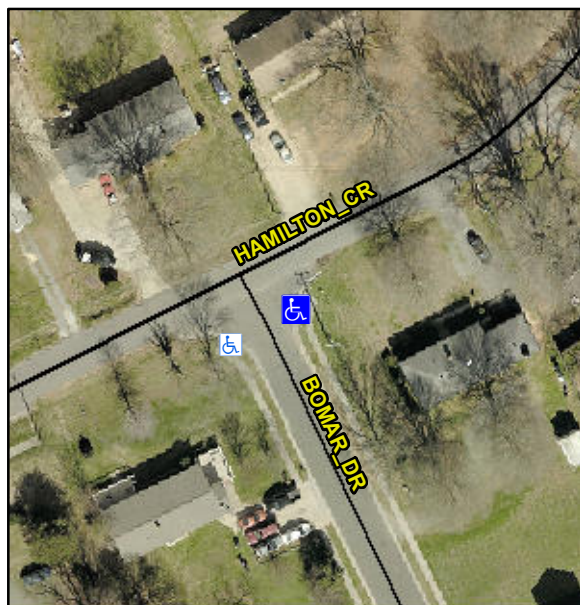
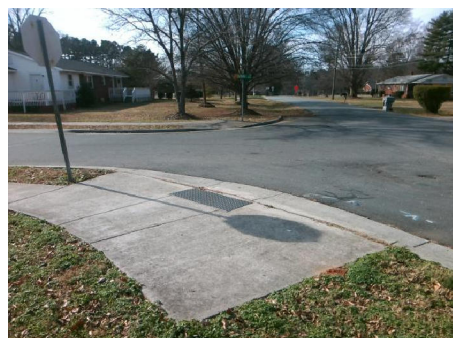
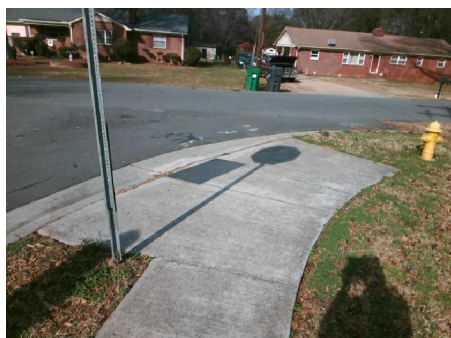
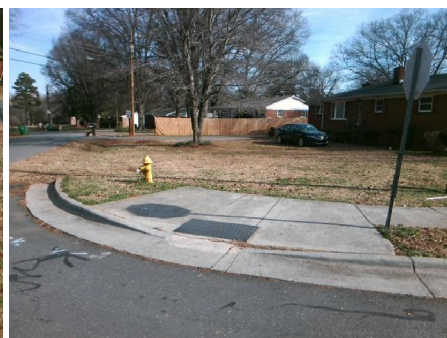
**Not Found, R304.5.1, R304.5.3**

Compliance	Description	Data	Compliance	Description	Data
N/A	Ramp Length (in)	97.0	Yes	Ramp Slope (%)	6.8
No	Ramp Width (in)	29.0	No	Ramp XSlope (%)	2.6
N/A	Flare Type LT	N/A	N/A	Flare Type RT	N/A
N/A	Flare Slope LT (%)	N/A	N/A	Flare Slope RT (%)	N/A
N/A	Flare Traversable LT?	N/A	N/A	Flare Traversable RT?	N/A
N/A	Landing Length (in)	N/A	N/A	DWS Provided?	N/A
N/A	Landing Width (in)	N/A	N/A	DWS Contrast?	N/A
N/A	Landing Slope (%)	N/A	N/A	DWS Length (in)	N/A
N/A	Landing X Slope (%)	N/A	N/A	DWS Full Width?	N/A
N/A	Landing Curb? (Y/N)	N/A	N/A	DWS Offset (in)	N/A
N/A	Shared Landing?	N/A			
N/A	Gutter Ponding?	N/A	N/A	Gutter Slope (%)	N/A
N/A	Gutter Lip Ht (in)	N/A	N/A	Gutter X Slope (%)	N/A
N/A	Painted X Walk1?	No	N/A	Painted X Walk2?	N/A
	X Walk 1 Direction	To SW		X Walk 2 Direction	N/A
N/A	X Walk 1 Width (in)	N/A	N/A	X Walk 2 Width (in)	N/A
	X Walk 1 Slope (%)	0.8		X Walk 2 Slope (%)	N/A
	X Walk 1 X Slope (%)	1.4		X Walk 2 X Slope (%)	N/A

N/A	Ramp inside XWalk1?	N/A	N/A	Ramp inside XWalk2?	N/A
	Road Slope (%)	N/A	N/A	Clear Space?	N/A
	Road X Slope (%)	N/A	N/A	Clear Space to XWalk (in)	N/A
N/A	Any Obstructions?	N/A	N/A	Storm Grate/Utility Hazard?	N/A
	Obstruction Type			Storm Grate/Utility Type	
		N/A			N/A
			Yes	Surface Condition? (G/P)	Good

**Remove & Replace Entire Ramp.**
