Access Compliance Report

Public Rights-of-Way

(Curb Ramps)

Intersection ID: 10036601	Main Street: RUSHMORE_DR	Cross Street: N/A	Location: NE
ADA ID: 8CFA006BE555	Ramp Type: Perp	Initial Pass/Fail: Fail	Overall Compliance: No
Codes/Mitigation Info/Possible Solution		Field Measurements/Component Compliance	
Severity Score: 55

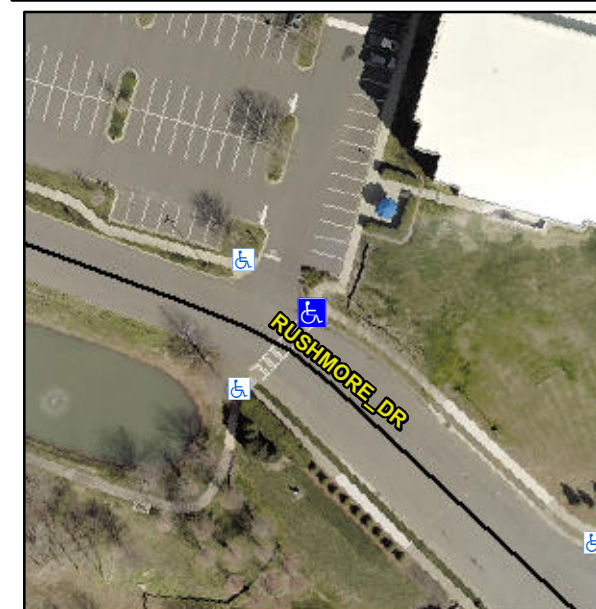
Not Found, R304.5.1, R304.2.2, R304.5.3

Compliance	Description	Data	Compliance	Description	Data
N/A	Ramp Length (in)	109.0	No	Ramp Slope (%)	9.9
No	Ramp Width (in)	32.0	No	Ramp XSlope (%)	9.9
N/A	Flare Type LT	N/A	N/A	Flare Type RT	N/A
N/A	Flare Slope LT (%)	N/A	N/A	Flare Slope RT (%)	N/A
N/A	Flare Traversable LT?	N/A	N/A	Flare Traversable RT?	N/A
N/A	Landing Length (in)	N/A	N/A	DWS Provided?	N/A
N/A	Landing Width (in)	N/A	N/A	DWS Contrast?	N/A
N/A	Landing Slope (%)	N/A	N/A	DWS Length (in)	N/A
N/A	Landing X Slope (%)	N/A	N/A	DWS Full Width?	N/A
N/A	Landing Curb? (Y/N)	N/A	N/A	DWS Offset (in)	N/A
N/A	Shared Landing?	N/A			
N/A	Gutter Ponding?	N/A	N/A	Gutter Slope (%)	N/A
N/A	Gutter Lip Ht (in)	N/A	N/A	Gutter X Slope (%)	N/A
N/A	Painted X Walk1?	Yes	N/A	Painted X Walk2?	N/A
	X Walk 1 Direction	To SW		X Walk 2 Direction	N/A
N/A	X Walk 1 Width (in)	87.0	N/A	X Walk 2 Width (in)	N/A
	X Walk 1 Slope (%)	2.9		X Walk 2 Slope (%)	N/A
	X Walk 1 X Slope (%)	4.5		X Walk 2 X Slope (%)	N/A

N/A	Ramp inside XWalk1?	Yes	N/A	Ramp inside XWalk2?	N/A
	Road Slope (%)	N/A	N/A	Clear Space?	N/A
	Road X Slope (%)	N/A	N/A	Clear Space to XWalk (in)	N/A
N/A	Any Obstructions?	N/A	N/A	Storm Grate/Utility Hazard?	N/A
	Obstruction Type			Storm Grate/Utility Type	
		N/A			N/A
			Yes	Surface Condition? (G/P)	Good

Possible Solutions:

Remove & Replace Entire Ramp.
