Access Compliance Report Public Rights-of-Way (Curb Ramps)

Intersection ID: 30448 Main Street: NANNYBERRY LN **Cross Street: WALLAND LN** Location: NE ADA ID: 8D0D7776F023 Ramp Type: PerpDiag Initial Pass/Fail: Fail **Overall Compliance: No** Severity Score: 21.25

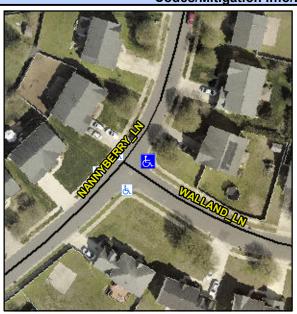
Field Measurements/Component Compliance						
Comp	Compliance Description		Comp	liance	Description	Data
N/A	Ramp Length (in)	47.0	Yes	Ramp	Slope (%)	6.8
No	Ramp Width (in)	46.0	No	Ramp	XSlope (%)	6.2
N/A	Flare Type LT	N/A	N/A	Flare	Type RT	N/A
N/A	Flare Slope LT (%)	N/A	N/A	Flare	Slope RT (%)	N/A
N/A	Flare Traversable LT?	N/A	N/A	Flare	Traversable RT?	N/A
N/A	Landing Length (in)	N/A	N/A	DWS	Provided?	N/A
N/A	Landing Width (in)	N/A	N/A	DWS	Contrast?	N/A
N/A	Landing Slope (%)	N/A	N/A	DWS	Length (in)	N/A
N/A	Landing X Slope (%)	N/A	N/A	DWS	Full Width?	N/A
N/A	Landing Curb? (Y/N)	N/A	N/A	DWS	Offset (in)	N/A
N/A	Shared Landing?	N/A				
N/A	Gutter Ponding?	N/A	N/A	Gutte	r Slope (%)	N/A
N/A	Gutter Lip Ht (in)	N/A	N/A	Gutte	r X Slope (%)	N/A
N/A	Painted X Walk1?	No	N/A	Paint	ed X Walk2?	No
	X Walk 1 Direction	To NW		X Wa	lk 2 Direction	To SW
N/A	X Walk 1 Width (in)	N/A	N/A	X Wa	lk 2 Width (in)	N/A
	X Walk 1 Slope (%)	1.6		X Wa	lk 2 Slope (%)	1.6

X Walk 1 X Slope (%)	2.3		X Wa	lk 2 X Slope (%)	3.3
N/A	Ramp inside XWalk1?	N/A	N/A	Ramp	inside XWalk2?	N/A
	Road Slope (%)	5.8	N/A	Clear	Space?	N/A
	Road X Slope (%)	3.8	N/A	Clear	Space to XWalk (in)	N/A
N/A	Any Obstructions?	N/A	N/A	Storm	Grate/Utility Hazard?	N/A
	Obstruction Type			Storm	n Grate/Utility Type	
		N/A				N/A
			Yes	Surfa	ce Condition? (G/P)	Good
1 300

Possible Solutions: Remove & Replace Curb Ramp With **Two New Directional Ramps or** Equivalent. Surveyor Notes: N/A PROW/ADA: Not Found, R304.5.1, R304.5.3
