# Access Compliance Report

## Public Rights-of-Way

### (Curb Ramps)

Intersection ID: 12186	Main Street: E_11TH_ST	Cross Street: E_BROOKSHIRE_FR_RA	Location:	N
ADA ID: 8D13124D94F8	Ramp Type: Perp	Initial Pass/Fail: Fail	Overall Compliance: No	Severity Score: 10

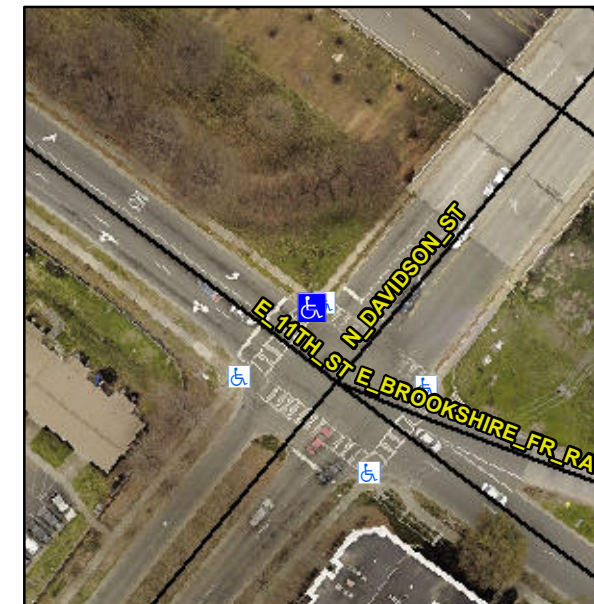
**Not Found, R304.5.1, R304.5.3**

Compliance	Description	Data	Compliance	Description	Data
N/A	Ramp Length (in)	43.0	Yes	Ramp Slope (%)	2.3
No	Ramp Width (in)	46.0	No	Ramp XSlope (%)	4.4
N/A	Flare Type LT	N/A	N/A	Flare Type RT	N/A
N/A	Flare Slope LT (%)	N/A	N/A	Flare Slope RT (%)	N/A
N/A	Flare Traversable LT?	N/A	N/A	Flare Traversable RT?	N/A
N/A	Landing Length (in)	N/A	N/A	DWS Provided?	N/A
N/A	Landing Width (in)	N/A	N/A	DWS Contrast?	N/A
N/A	Landing Slope (%)	N/A	N/A	DWS Length (in)	N/A
N/A	Landing X Slope (%)	N/A	N/A	DWS Full Width?	N/A
N/A	Landing Curb? (Y/N)	N/A	N/A	DWS Offset (in)	N/A
N/A	Shared Landing?	N/A			
N/A	Gutter Ponding?	N/A	N/A	Gutter Slope (%)	N/A
N/A	Gutter Lip Ht (in)	N/A	N/A	Gutter X Slope (%)	N/A
N/A	Painted X Walk1?	Yes	N/A	Painted X Walk2?	N/A
	X Walk 1 Direction	To SW		X Walk 2 Direction	N/A
N/A	X Walk 1 Width (in)	120.0	N/A	X Walk 2 Width (in)	N/A
	X Walk 1 Slope (%)	3.0		X Walk 2 Slope (%)	N/A
	X Walk 1 X Slope (%)	3.7		X Walk 2 X Slope (%)	N/A

N/A	Ramp inside XWalk1?	Yes	N/A	Ramp inside XWalk2?	N/A
	Road Slope (%)	N/A	N/A	Clear Space?	N/A
	Road X Slope (%)	N/A	N/A	Clear Space to XWalk (in)	N/A
N/A	Any Obstructions?	N/A	N/A	Storm Grate/Utility Hazard?	N/A
	Obstruction Type			Storm Grate/Utility Type	
		N/A			N/A
			Yes	Surface Condition? (G/P)	Good

**Remove & Replace Entire Ramp.**

Total Cost: \$ 1850.00
