# Access Compliance Report

## Public Rights-of-Way

| Intersection ID: 3804 | Main Street: MT_ISLE_HARBOR_DR | Cross Street: WRANGELL_LN | Location: | E |
| ADA ID: 8D206A2C172E | Ramp Type: Perp | Initial Pass/Fail: Fail | Overall Compliance: No | Severity Score: 12.5 |

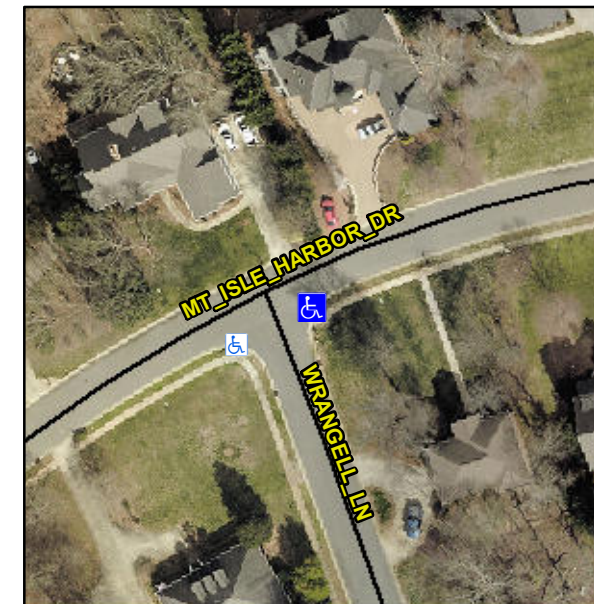
**Not Found, R304.5.3**

| Compliance | Description | Data | Compliance | Description | Data |
|---|---|---|---|---|---|
| N/A | Ramp Length (in) | 46.0 | Yes | Ramp Slope (%) | 8.0 |
| Yes | Ramp Width (in) | 55.0 | No | Ramp XSlope (%) | 6.1 |

**Remove & Replace Entire Ramp.**

Total Cost: \$ 1850.00
