# Access Compliance Report

## Public Rights-of-Way

### (Curb Ramps)

| Intersection ID: 3474 | Main Street: W_W_T_HARRIS_BV | Cross Street: W_WT_HARRIS_TO_I-77_RA_NB | Location: SW |

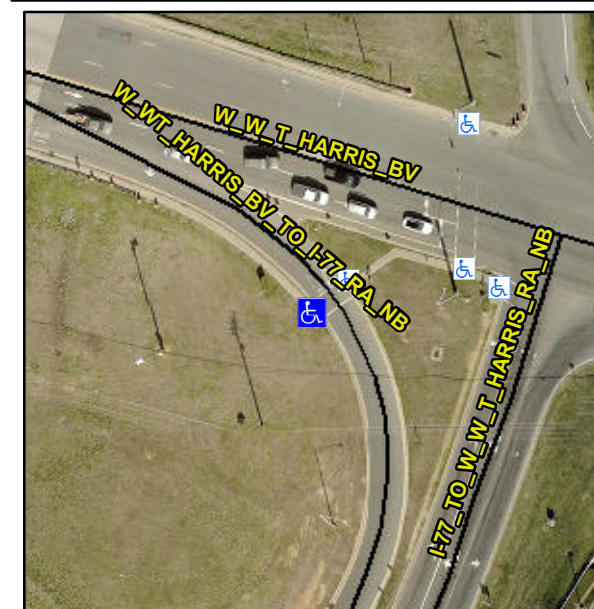
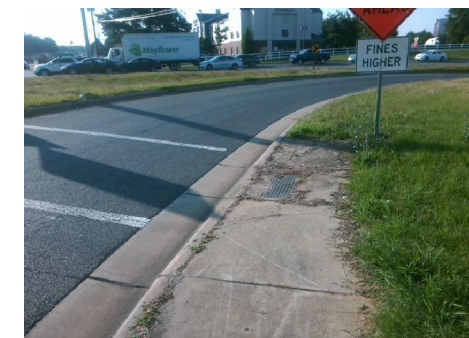
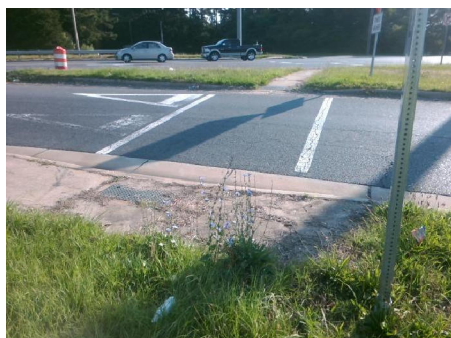
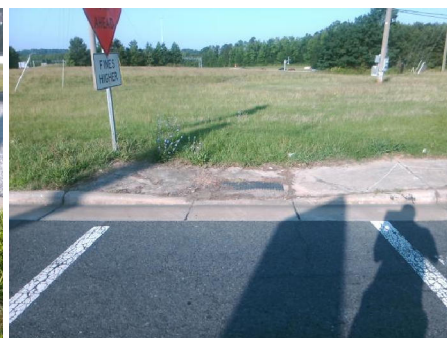
**NO LT SW**

**R304.5.3, R305.1.4, R305.2**

| Compliance | Description | Data | Compliance | Description | Data |
|---|---|---|---|---|---|
| No | Ramp XSlope LT (%) | 2.5 | Yes | Ramp XSlope RT (%) | 1.8 |
| Yes | Landing X Slope (%) | 1.1 | No | DWS Full Width? | No |
| N/A | Landing Curb? (Y/N) | No | No | DWS Offset (in) | 2.5 |
| Yes | Gutter Lip Ht (in) | 0.0 | No | Gutter X Slope (%) | 2.1 |

**Remove & Replace Entire Ramp.  
Remove & Replace Gutter.**
