Access Compliance Report

Public Rights-of-Way

(Curb Ramps)

Intersection ID: 17730	Main Street: AMELIA_DR	Cross Street: PINEY_GROVE_RD	Location: NE
ADA ID: 8D25C3731E15	Ramp Type: BlendTrans1	Initial Pass/Fail: Fail	Overall Compliance: No
		Severity Score: 10

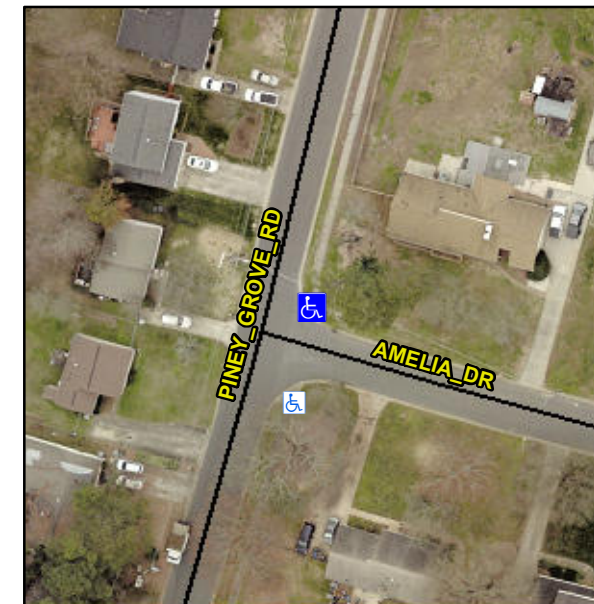
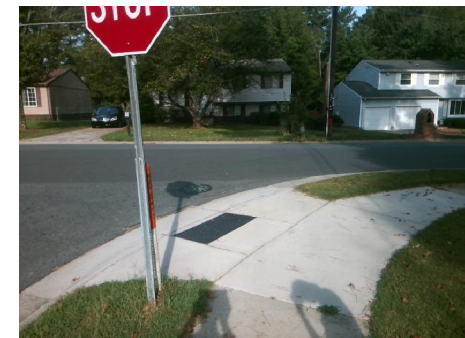
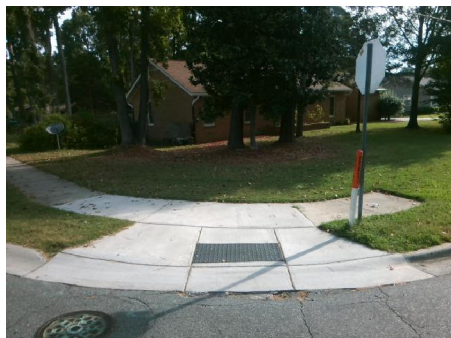
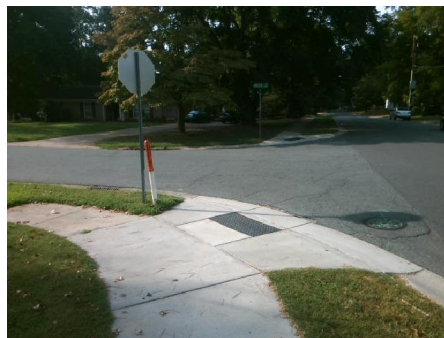
Compliance	Description	Data	Compliance	Description	Data
N/A	Ramp Length (in)	54.0	Yes	BlendTrans Slope (%)	3.8
No	Ramp Width (in)	46.5	No	BlendTrans XSlope (%)	3.0
N/A	Flare Type LT	N/A	N/A	Flare Type RT	N/A
N/A	Flare Slope LT (%)	N/A	N/A	Flare Slope RT (%)	N/A
N/A	Flare Traversable LT?	N/A	N/A	Flare Traversable RT?	N/A
N/A	Landing Length (in)	N/A	N/A	DWS Provided?	N/A
N/A	Landing Width (in)	N/A	N/A	DWS Contrast?	N/A
N/A	Landing Slope (%)	N/A	N/A	DWS Length (in)	N/A
N/A	Landing X Slope (%)	N/A	N/A	DWS Full Width?	N/A
N/A	Landing Curb? (Y/N)	N/A	N/A	DWS Offset (in)	N/A
N/A	Shared Landing?	N/A			
N/A	Gutter Ponding?	N/A	N/A	Gutter Slope (%)	N/A
N/A	Gutter Lip Ht (in)	0.5	N/A	Gutter X Slope (%)	N/A
N/A	Painted X Walk1?	No	N/A	Painted X Walk2?	No
	X Walk 1 Direction	To NW		X Walk 2 Direction	To SW
	X Walk 1 Width (in)	N/A		X Walk 2 Width (in)	N/A
	X Walk 1 Slope (%)	7.1		X Walk 2 Slope (%)	2.8
	X Walk 1 X Slope (%)	0.5		X Walk 2 X Slope (%)	5.4

N/A	Ramp inside XWalk1?	N/A	N/A	Ramp inside XWalk2?	N/A
	Road Slope (%)	2.1		Clear Space?	N/A
	Road X Slope (%)	6.1	N/A	Clear Space to XWalk (in)	N/A
N/A	Any Obstructions?	N/A	N/A	Storm Grate/Utility Hazard?	N/A
	Obstruction Type			Storm Grate/Utility Type	
		N/A			N/A
			Yes	Surface Condition? (G/P)	Good
			N/A	Curb Slope (%)	3.7

Remove & Replace Curb Ramp With Two New Directional Ramps or Equivalent.

R304.5.1, R304.5.3
