Access Compliance Report

Public Rights-of-Way

(Curb Ramps)

Intersection ID: 18769	Main Street: BARCLAY_DOWNS_DR	Cross Street: RUNNYMEDE_LN	Location: NE
ADA ID: 8D2DE9981833	Ramp Type: Perp	Initial Pass/Fail: Fail	Overall Compliance: No
			Severity Score: 13.75

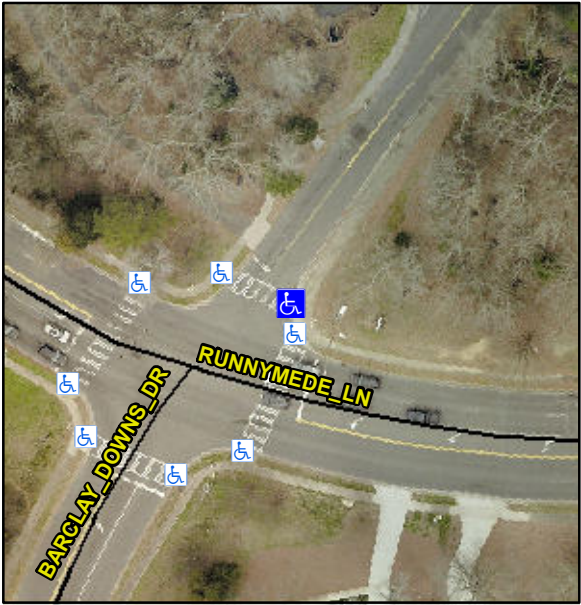
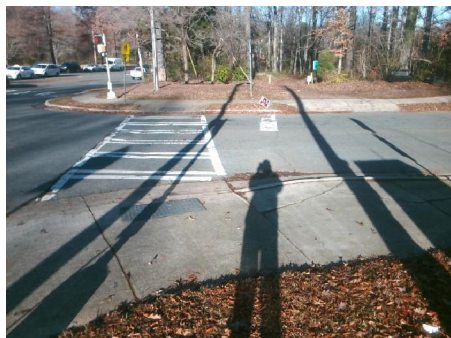
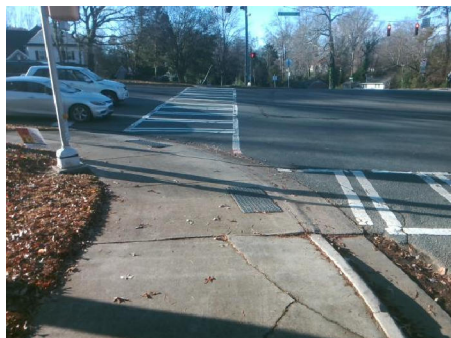
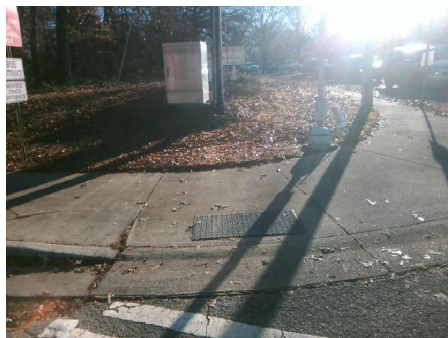
Possible Solutions:		Compliance	Description	Data
	Remove & Replace Entire Ramp.		No	Ramp Length (in)	109.0
			Yes	Ramp Width (in)	75.0
			N/A	Flare Type LT	N/A
			N/A	Flare Slope LT (%)	N/A
			N/A	Flare Traversable LT?	N/A
			N/A	Landing Length (in)	N/A
			N/A	Landing Width (in)	N/A
			N/A	Landing Slope (%)	N/A
			N/A	Landing X Slope (%)	N/A
<p>Surveyor Notes:</p> <p>N/A</p> <p>PROW/ADA:</p> <p>Not Found, R304.2.2, R304.5.3</p>			N/A	Flare Type RT	N/A
			N/A	Flare Slope RT (%)	N/A
			N/A	Flare Traversable RT?	N/A
			N/A	DWS Provided?	N/A
			N/A	DWS Contrast?	N/A
			N/A	DWS Length (in)	N/A
			N/A	DWS Full Width?	N/A
			N/A	DWS Offset (in)	N/A
			N/A	Gutter Ponding?	N/A
			N/A	Gutter Lip Ht (in)	N/A
			N/A	Painted X Walk1?	Yes
				X Walk 1 Direction	To NW
			N/A	X Walk 1 Width (in)	116.0
				X Walk 1 Slope (%)	4.2
				X Walk 1 X Slope (%)	0.5

N/A	Ramp inside XWalk1?	Yes
			N/A	Road Slope (%)	N/A
			N/A	Road X Slope (%)	N/A
			N/A	Any Obstructions?	N/A
				Obstruction Type	
Total Cost:					
		\$ 1850.00			
			N/A	Clear Space?	N/A
			N/A	Clear Space to XWalk (in)	N/A
			N/A	Storm Grate/Utility Hazard?	N/A
				Storm Grate/Utility Type	
			N/A		N/A
			Yes	Surface Condition? (G/P)	Good
