# Access Compliance Report

## Public Rights-of-Way

### (Curb Ramps)

Intersection ID: 30559	Main Street: FALLING_MEADOWS_LN	Cross Street: GREENCREEK_DR	Location: E
ADA ID: 8D349A72DF7E	Ramp Type: PerpDiag	Initial Pass/Fail: Fail	Overall Compliance: No
Severity Score: 12.5			
Codes/Mitigation Info/Possible Solution		Field Measurements/Component Compliance

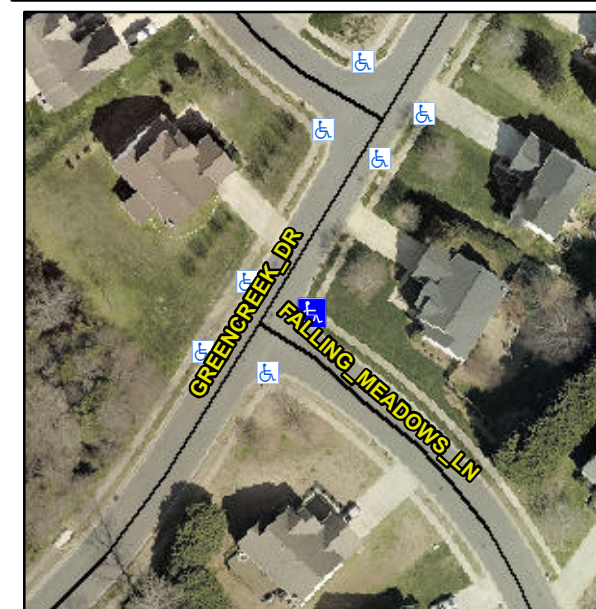
Compliance	Description	Data	Compliance	Description	Data
N/A	Ramp Length (in)	44.0	No	Ramp Slope (%)	8.6
Yes	Ramp Width (in)	48.0	Yes	Ramp XSlope (%)	0.1
N/A	Flare Type LT	N/A	N/A	Flare Type RT	N/A
N/A	Flare Slope LT (%)	N/A	N/A	Flare Slope RT (%)	N/A
N/A	Flare Traversable LT?	N/A	N/A	Flare Traversable RT?	N/A
N/A	Landing Length (in)	N/A	N/A	DWS Provided?	N/A
N/A	Landing Width (in)	N/A	N/A	DWS Contrast?	N/A
N/A	Landing Slope (%)	N/A	N/A	DWS Length (in)	N/A
N/A	Landing X Slope (%)	N/A	N/A	DWS Full Width?	N/A
N/A	Landing Curb? (Y/N)	N/A	N/A	DWS Offset (in)	N/A
N/A	Shared Landing?	N/A			
N/A	Gutter Ponding?	N/A	N/A	Gutter Slope (%)	N/A
N/A	Gutter Lip Ht (in)	N/A	N/A	Gutter X Slope (%)	N/A
N/A	Painted X Walk1?	No	N/A	Painted X Walk2?	No
	X Walk 1 Direction	To NW		X Walk 2 Direction	To SW
N/A	X Walk 1 Width (in)	N/A	N/A	X Walk 2 Width (in)	N/A
	X Walk 1 Slope (%)	1.2		X Walk 2 Slope (%)	0.6
	X Walk 1 X Slope (%)	1.4		X Walk 2 X Slope (%)	0.7

N/A	Ramp inside XWalk1?	N/A	N/A	Ramp inside XWalk2?	N/A
	Road Slope (%)	0.9	N/A	Clear Space?	N/A
	Road X Slope (%)	1.4	N/A	Clear Space to XWalk (in)	N/A
N/A	Any Obstructions?	N/A	N/A	Storm Grate/Utility Hazard?	N/A
	Obstruction Type			Storm Grate/Utility Type	
		N/A			N/A
			Yes	Surface Condition? (G/P)	Good

Possible Solutions:

**Remove & Replace Curb Ramp With Two New Directional Ramps or Equivalent.**

**R304.2.2**
