Access Compliance Report

Public Rights-of-Way

(Curb Ramps)

Intersection ID: 18956	Main Street: N_I-77_EXIT_5_RA	Cross Street: TYVOLA_RD	Location: S
ADA ID: 8D367A9EA105	Ramp Type: Perp	Initial Pass/Fail: Fail	Overall Compliance: No
Severity Score: 12.5			
Codes/Mitigation Info/Possible Solution		Field Measurements/Component Compliance

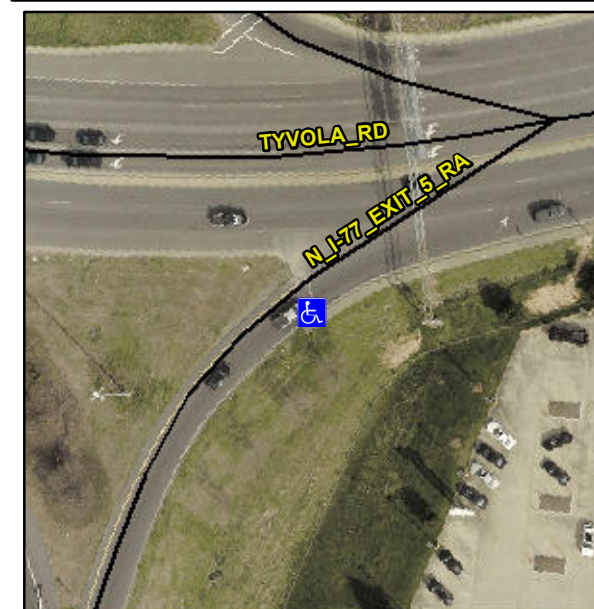
Not Found, R304.2.2

Compliance	Description	Data	Compliance	Description	Data
N/A	Ramp Length (in)	58.0	No	Ramp Slope (%)	8.7
Yes	Ramp Width (in)	58.0	Yes	Ramp XSlope (%)	1.6
N/A	Flare Type LT	N/A	N/A	Flare Type RT	N/A
N/A	Flare Slope LT (%)	N/A	N/A	Flare Slope RT (%)	N/A
N/A	Flare Traversable LT?	N/A	N/A	Flare Traversable RT?	N/A
N/A	Landing Length (in)	N/A	N/A	DWS Provided?	N/A
N/A	Landing Width (in)	N/A	N/A	DWS Contrast?	N/A
N/A	Landing Slope (%)	N/A	N/A	DWS Length (in)	N/A
N/A	Landing X Slope (%)	N/A	N/A	DWS Full Width?	N/A
N/A	Landing Curb? (Y/N)	N/A	N/A	DWS Offset (in)	N/A
N/A	Shared Landing?	N/A			
N/A	Gutter Ponding?	N/A	N/A	Gutter Slope (%)	N/A
N/A	Gutter Lip Ht (in)	N/A	N/A	Gutter X Slope (%)	N/A
N/A	Painted X Walk1?	Yes	N/A	Painted X Walk2?	N/A
	X Walk 1 Direction	To N		X Walk 2 Direction	N/A
N/A	X Walk 1 Width (in)	67.0	N/A	X Walk 2 Width (in)	N/A
	X Walk 1 Slope (%)	1.1		X Walk 2 Slope (%)	N/A
	X Walk 1 X Slope (%)	0.8		X Walk 2 X Slope (%)	N/A

N/A	Ramp inside XWalk1?	Yes	N/A	Ramp inside XWalk2?	N/A
	Road Slope (%)	N/A	N/A	Clear Space?	N/A
	Road X Slope (%)	N/A	N/A	Clear Space to XWalk (in)	N/A
N/A	Any Obstructions?	N/A	N/A	Storm Grate/Utility Hazard?	N/A
	Obstruction Type			Storm Grate/Utility Type	
		N/A			N/A
		Yes		Surface Condition? (G/P)	Good

Possible Solutions:

Remove & Replace Entire Ramp.
