Access Compliance Report

Public Rights-of-Way

(Curb Ramps)

Intersection ID: 2711	Main Street: FAIRWAY_POINT_DR	Cross Street: RAVENCREST_DR	Location: NE
ADA ID: 8D456350BFE6	Ramp Type: BlendTrans1	Initial Pass/Fail: Fail	Overall Compliance: No
Severity Score: 33.75			
Codes/Mitigation Info/Possible Solution		Field Measurements/Component Compliance

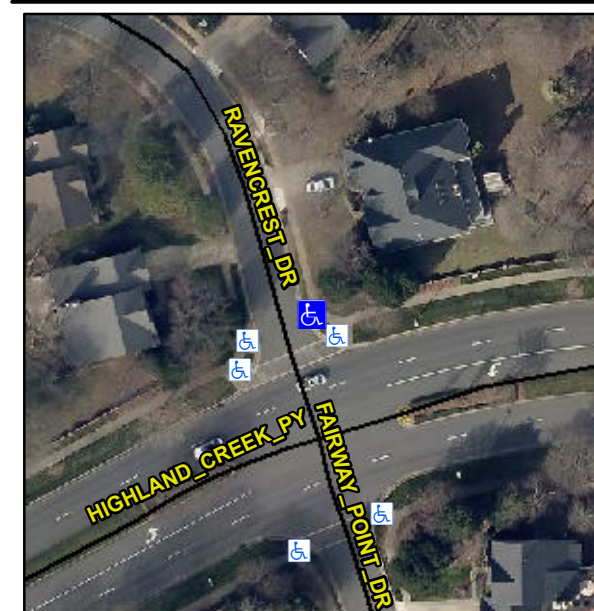
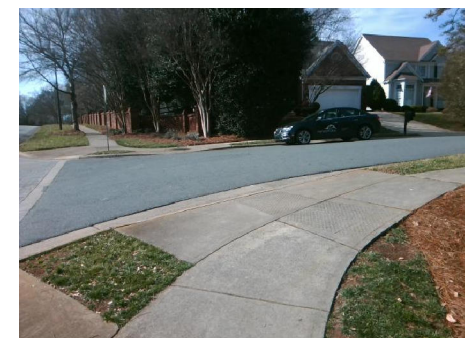
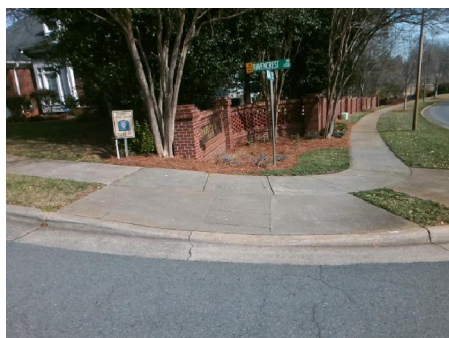
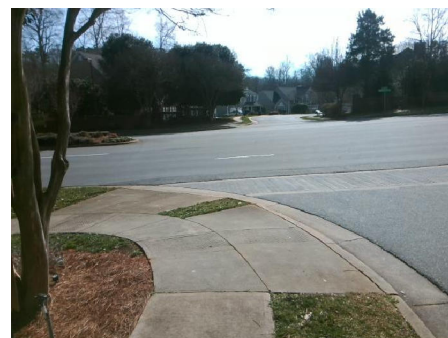
Not Found, R304.5.1, R304.5.3

Compliance	Description	Data	Compliance	Description	Data
N/A	Ramp Length (in)	59.0	Yes	BlendTrans Slope (%)	2.1
No	Ramp Width (in)	36.0	No	BlendTrans XSlope (%)	12.1
N/A	Flare Type LT	N/A	N/A	Flare Type RT	N/A
N/A	Flare Slope LT (%)	N/A	N/A	Flare Slope RT (%)	N/A
N/A	Flare Traversable LT?	N/A	N/A	Flare Traversable RT?	N/A
N/A	Landing Length (in)	N/A	N/A	DWS Provided?	N/A
N/A	Landing Width (in)	N/A	N/A	DWS Contrast?	N/A
N/A	Landing Slope (%)	N/A	N/A	DWS Length (in)	N/A
N/A	Landing X Slope (%)	N/A	N/A	DWS Full Width?	N/A
N/A	Landing Curb? (Y/N)	N/A	N/A	DWS Offset (in)	N/A
N/A	Shared Landing?	N/A			
N/A	Gutter Ponding?	N/A	N/A	Gutter Slope (%)	N/A
N/A	Gutter Lip Ht (in)	N/A	N/A	Gutter X Slope (%)	N/A
N/A	Painted X Walk1?	No	N/A	Painted X Walk2?	N/A
	X Walk 1 Direction	To W		X Walk 2 Direction	N/A
	X Walk 1 Width (in)	N/A		X Walk 2 Width (in)	N/A
	X Walk 1 Slope (%)	3.7		X Walk 2 Slope (%)	N/A
	X Walk 1 X Slope (%)	8.8		X Walk 2 X Slope (%)	N/A

N/A	Ramp inside XWalk1?	N/A	N/A	Ramp inside XWalk2?	N/A
	Road Slope (%)	8.8		Clear Space?	N/A
	Road X Slope (%)	3.7	N/A	Clear Space to XWalk (in)	N/A
N/A	Any Obstructions?	N/A	N/A	Storm Grate/Utility Hazard?	N/A
	Obstruction Type			Storm Grate/Utility Type	
		N/A			N/A
			Yes	Surface Condition? (G/P)	Good
			No	Curb Slope (%)	10.7

Remove & Replace Curb Ramp With Two New Directional Ramps or Equivalent.
