# Access Compliance Report

## Public Rights-of-Way

### (Curb Ramps)

| Intersection ID: 6310 | Main Street: LAKE_DR | Cross Street: NEVIN_RD | Location: | S |

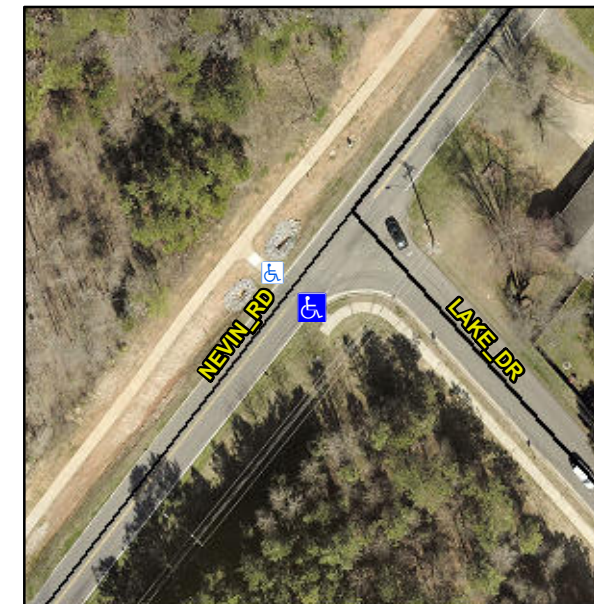
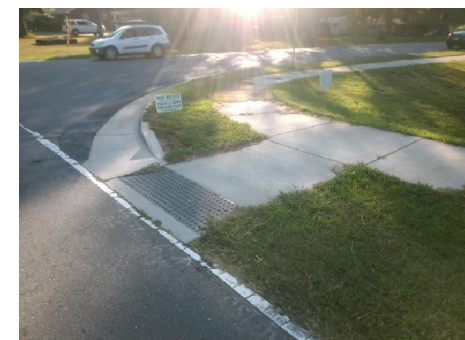
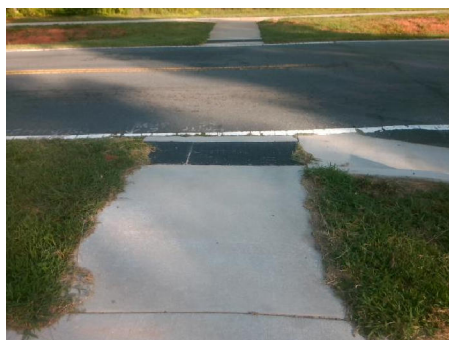
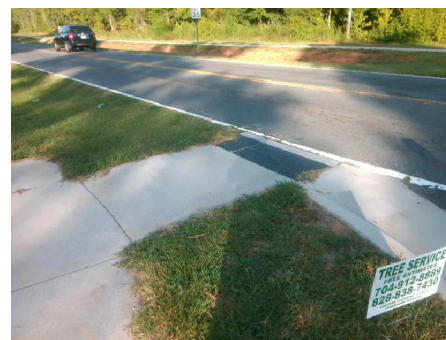
**DWS PLACED IN GTR, DWS OS MEASURED TO ASP**

| Compliance | Description | Data | Compliance | Description | Data |
|---|---|---|---|---|---|
| N/A | Landing Curb? (Y/N) | No | No | DWS Offset (in) | 7.0 |
| No | Gutter Lip Ht (in) | 0.8 | Yes | Gutter X Slope (%) | 0.6 |

**Remove & Replace Detectable Warning System. Grind Gutter Lip.**
