Access Compliance Report Public Rights-of-Way (Curb Ramps)

Intersection ID: 54151 Main Street: SANDERS_FARM_LN Cross Street: WALNUT_FOREST_DR Location: SE

ADA ID: 8D64A9847362 Ramp Type: Perp Initial Pass/Fail: Fail Overall Compliance: No Severity Score: 8.75

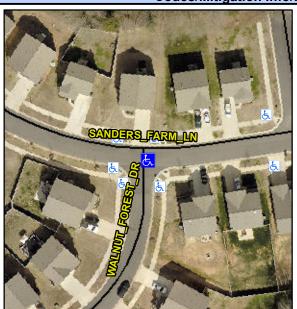
Possible Solution				Fleid Measurements/Component Compliance					
Possible Solutions:			Compliance Description		Data	Comp	liance	Description	
Remove & Replace Entire	Ramı	p.	N/A	Ramp Length (in)	96.0	Yes	Ram	o Slope (%)

•	No	Ramp Width (in)	44.5	Yes	Ram	xSlope (%)	
			N/A	Flare Type LT	N/A	N/A	Flare	Type RT	
			N/A	Flare Slope LT (%)	N/A	N/A	Flare	Slope RT (%)	
			N/A	Flare Traversable LT?	N/A	N/A	Flare	Traversable RT?	
			N/A	Landing Length (in)	N/A	N/A	DWS	Provided?	
Surveyor Notes:			N/A	Landing Width (in)	N/A	N/A	DWS	Contrast?	
N/A			N/A	Landing Slope (%)	N/A	N/A	DWS	Length (in)	
			N/A	Landing X Slope (%)	N/A	N/A	DWS	Full Width?	
1			N/A	Landing Curb? (Y/N)	N/A	N/A	DWS	Offset (in)	
			N/A	Shared Landing?	N/A				
PROW/ADA:			N/A	Gutter Ponding?	N/A	N/A	Gutte	er Slope (%)	
Not Found, R304.5.1			N/A	Gutter Lip Ht (in)	1.0	N/A	Gutte	er X Slope (%)	
			N/A	Painted X Walk1?	No	N/A	Paint	ed X Walk2?	
				X Walk 1 Direction	To N		X Wa	lk 2 Direction	
a a			N/A	X Walk 1 Width (in)	N/A	N/A	X Wa	ılk 2 Width (in)	
				X Walk 1 Slope (%)	2.6		X Wa	ılk 2 Slope (%)	
				X Walk 1 X Slope (%)	3.4		X Wa	ılk 2 X Slope (%)	
			N/A	Ramp inside XWalk1?	N/A	N/A	Ram	p inside XWalk2?
