Access Compliance Report

Public Rights-of-Way

(Curb Ramps)

Intersection ID: 26636	Main Street: SAVANNAH_HILLS_DR	Cross Street: HAMPTON_GLEN_CT	Location: SW
ADA ID: 8D6D2CF0537F	Ramp Type: BlendTrans1	Initial Pass/Fail: Fail	Overall Compliance: No
			Severity Score: 21.25

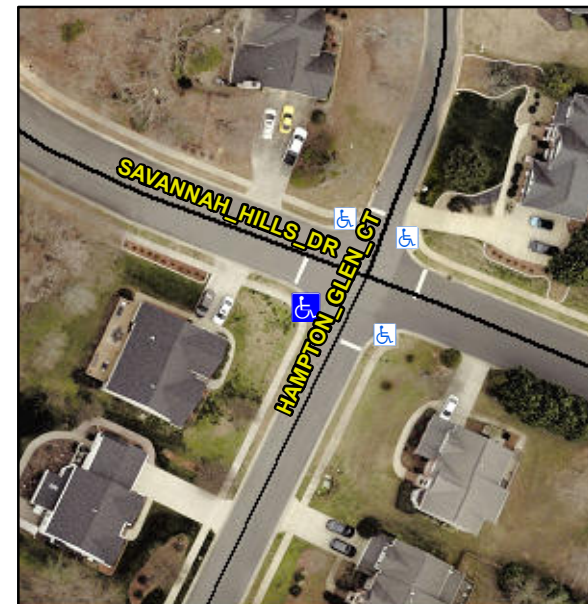
Compliance	Description	Data	Compliance	Description	Data
N/A	Ramp Length (in)	51.0	Yes	BlendTrans Slope (%)	2.7
No	Ramp Width (in)	45.0	No	BlendTrans XSlope (%)	5.4
N/A	Flare Type LT	N/A	N/A	Flare Type RT	N/A
N/A	Flare Slope LT (%)	N/A	N/A	Flare Slope RT (%)	N/A
N/A	Flare Traversable LT?	N/A	N/A	Flare Traversable RT?	N/A
N/A	Landing Length (in)	N/A	N/A	DWS Provided?	N/A
N/A	Landing Width (in)	N/A	N/A	DWS Contrast?	N/A
N/A	Landing Slope (%)	N/A	N/A	DWS Length (in)	N/A
N/A	Landing X Slope (%)	N/A	N/A	DWS Full Width?	N/A
N/A	Landing Curb? (Y/N)	N/A	N/A	DWS Offset (in)	N/A
N/A	Shared Landing?	N/A			
N/A	Gutter Ponding?	N/A	N/A	Gutter Slope (%)	N/A
N/A	Gutter Lip Ht (in)	N/A	N/A	Gutter X Slope (%)	N/A
N/A	Painted X Walk1?	No	N/A	Painted X Walk2?	No
	X Walk 1 Direction	To SE		X Walk 2 Direction	To NE
	X Walk 1 Width (in)	N/A		X Walk 2 Width (in)	N/A
	X Walk 1 Slope (%)	5.2		X Walk 2 Slope (%)	6.5
	X Walk 1 X Slope (%)	6.1		X Walk 2 X Slope (%)	2.7

Remove & Replace Curb Ramp With Two New Directional Ramps or Equivalent.

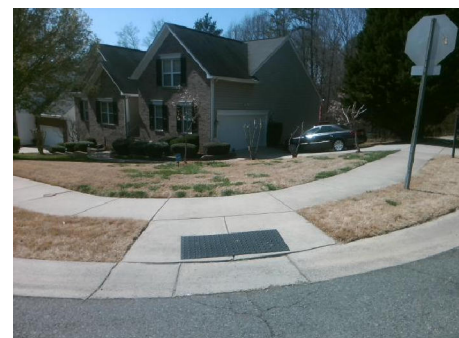
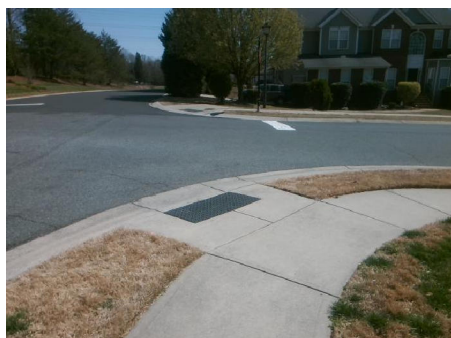
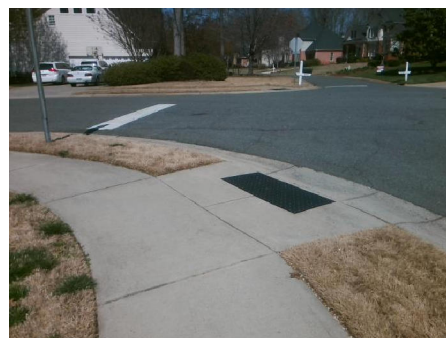
Not Found, R304.5.1, R304.5.3

N/A	Ramp inside XWalk1?	N/A	N/A	Ramp inside XWalk2?	N/A
	Road Slope (%)	4.2		Clear Space?	N/A
	Road X Slope (%)	7.4	N/A	Clear Space to XWalk (in)	N/A
N/A	Any Obstructions?	N/A	N/A	Storm Grate/Utility Hazard?	N/A
	Obstruction Type			Storm Grate/Utility Type	
		N/A			N/A
			Yes	Surface Condition? (G/P)	Good
			No	Curb Slope (%)	10.2
