# Access Compliance Report

## Public Rights-of-Way

### (Curb Ramps)

Intersection ID: 8660	Main Street: GENERAL_COMMERCE_DR	Cross Street: INDUSTRIAL_CENTER_CR	Location: SW
ADA ID: 8D7221009497	Ramp Type: Combination1	Initial Pass/Fail: Pass	Overall Compliance: No
Codes/Mitigation Info/Possible Solution		Field Measurements/Component Compliance	
Severity Score: 19.25

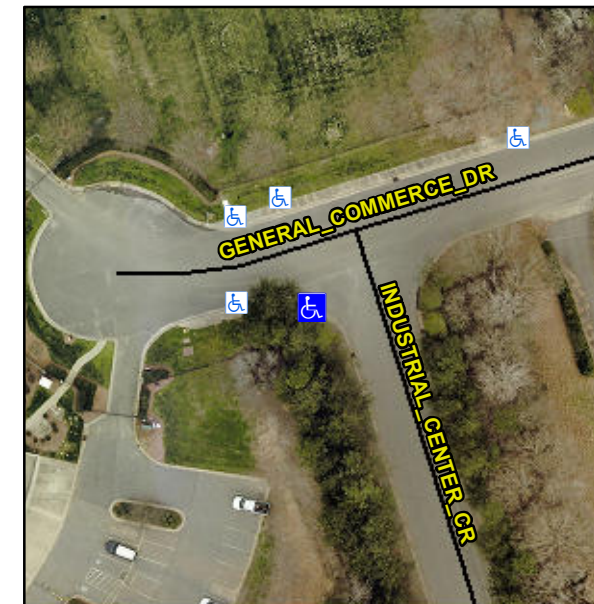
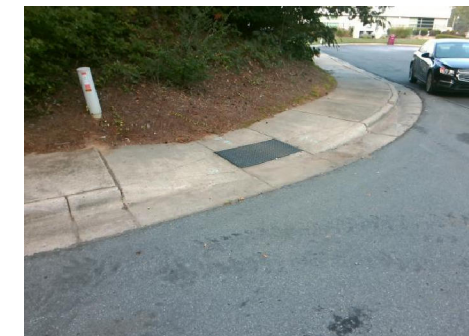
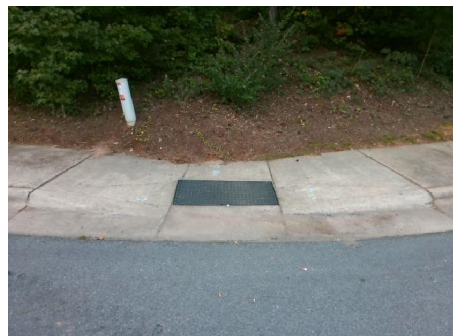
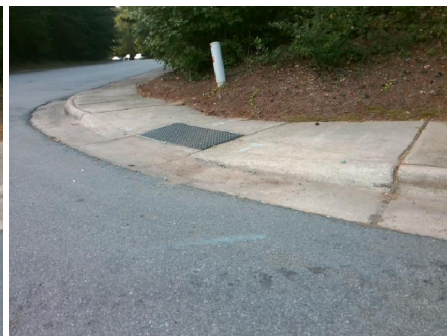
**GTR LIP 1.0", LT RP < 5%**

**Not Found, R304.5.3, R304.2.1,  
R304.2.2-Perp, R304.3.2-Para,  
R302.7, R302.7.2**

Compliance	Description	Data	Compliance	Description	Data
N/A	Ramp Length LT (in)	54.0	N/A	Ramp Length RT (in)	58.0
Yes	Ramp Width LT (in)	59.0	Yes	Ramp Width RT (in)	60.5
Yes	Ramp Slope LT (%)	4.8	Yes	Ramp Slope RT (%)	8.1
No	Ramp XSlope LT (%)	3.2	No	Ramp XSlope RT (%)	2.2
N/A	Ramp Length (in)	27.0	Yes	Ramp Slope (%)	8.0
Yes	Ramp Width (in)	48.0	Yes	Ramp XSlope (%)	0.3
N/A	Flare Type LT	Sloped	N/A	Flare Type RT	Sloped
Yes	Flare Slope LT (%)	6.3	Yes	Flare Slope RT (%)	4.8
N/A	Flare Traversable LT?	Yes	N/A	Flare Traversable RT?	Yes
No	Landing Length (in)	35.0	Yes	DWS Provided?	Yes
No	Landing Width (in)	46.5	Yes	DWS Contrast?	Yes
No	Landing Slope (%)	2.4	Yes	DWS Length (in)	25.5
No	Landing X Slope (%)	3.3	Yes	DWS Full Width?	Yes
N/A	Landing Curb? (Y/N)	No	Yes	DWS Offset (in)	0.0
N/A	Shared Landing?	No			
No	Gutter Ponding?	Yes	Yes	Gutter Slope (%)	1.6
No	Gutter Lip Ht (in)	1.0	Yes	Gutter X Slope (%)	0.6
N/A	Painted X Walk1?	No	N/A	Painted X Walk2?	N/A

**Remove & Replace Entire Ramp.  
Remove & Replace Sidewalk.**
