Access Compliance Report

Public Rights-of-Way (Curb Ramps)

Intersection ID: 2852	Main Street: EDINMEADOW_LN	Cross Street: HUNTMEADOW_DR	Location: NE
ADA ID: 8D74B1C6BE1F	Ramp Type: BlendTrans1	Initial Pass/Fail: Fail	Overall Compliance: No
		Severity Score: 1.25

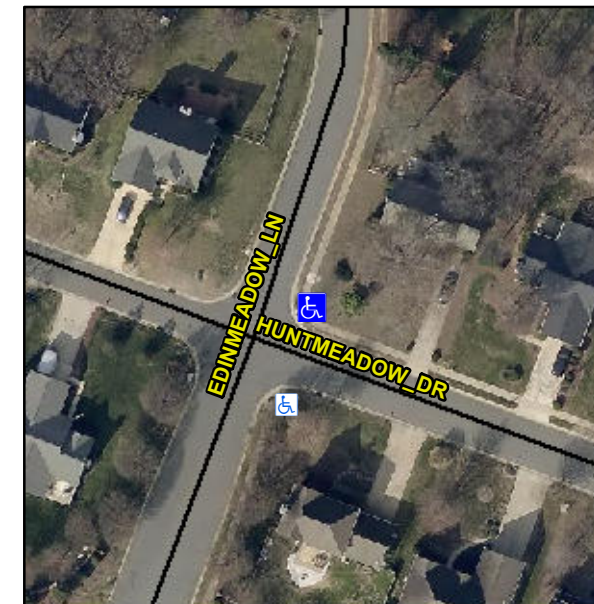
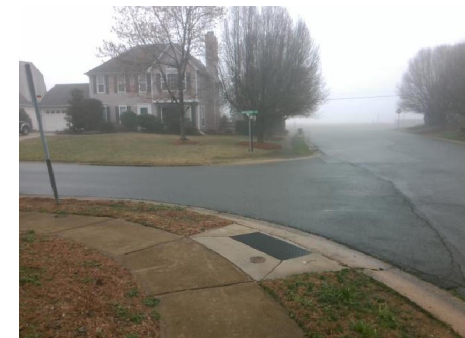
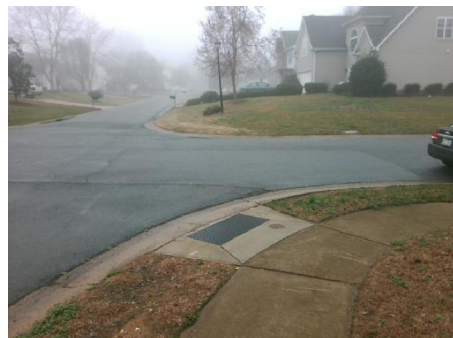
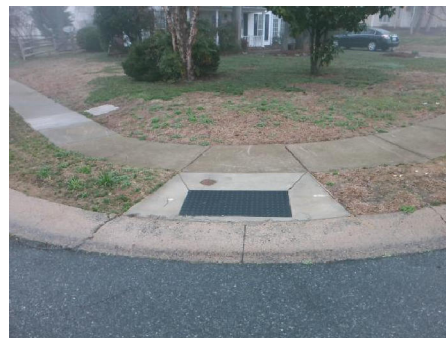
Not Found, R304.5.3

Compliance	Description	Data	Compliance	Description	Data
N/A	Ramp Length (in)	50.0	Yes	BlendTrans Slope (%)	4.4
Yes	Ramp Width (in)	48.0	No	BlendTrans XSlope (%)	2.7
N/A	Flare Type LT	N/A	N/A	Flare Type RT	N/A
N/A	Flare Slope LT (%)	N/A	N/A	Flare Slope RT (%)	N/A
N/A	Flare Traversable LT?	N/A	N/A	Flare Traversable RT?	N/A
N/A	Landing Length (in)	N/A	N/A	DWS Provided?	N/A
N/A	Landing Width (in)	N/A	N/A	DWS Contrast?	N/A
N/A	Landing Slope (%)	N/A	N/A	DWS Length (in)	N/A
N/A	Landing X Slope (%)	N/A	N/A	DWS Full Width?	N/A
N/A	Landing Curb? (Y/N)	N/A	N/A	DWS Offset (in)	N/A
N/A	Shared Landing?	N/A			
N/A	Gutter Ponding?	N/A	N/A	Gutter Slope (%)	N/A
N/A	Gutter Lip Ht (in)	N/A	N/A	Gutter X Slope (%)	N/A
N/A	Painted X Walk1?	No	N/A	Painted X Walk2?	N/A
	X Walk 1 Direction	To S		X Walk 2 Direction	N/A
	X Walk 1 Width (in)	N/A		X Walk 2 Width (in)	N/A
	X Walk 1 Slope (%)	6.8		X Walk 2 Slope (%)	N/A
	X Walk 1 X Slope (%)	0.8		X Walk 2 X Slope (%)	N/A

N/A	Ramp inside XWalk1?	N/A	N/A	Ramp inside XWalk2?	N/A
	Road Slope (%)	0.8		Clear Space?	N/A
	Road X Slope (%)	6.8	N/A	Clear Space to XWalk (in)	N/A
N/A	Any Obstructions?	N/A	N/A	Storm Grate/Utility Hazard?	N/A
	Obstruction Type			Storm Grate/Utility Type	
		N/A			N/A
			Yes	Surface Condition? (G/P)	Good
			No	Curb Slope (%)	12.8

Remove & Replace Curb Ramp With Two New Directional Ramps or Equivalent.

Total Cost: \$ 3200.00
