# Access Compliance Report

## Public Rights-of-Way

### (Curb Ramps)

| Intersection ID: 44303 | Main Street: PAULINE_LN | Cross Street: THOMPSON_RD | Location: NE |

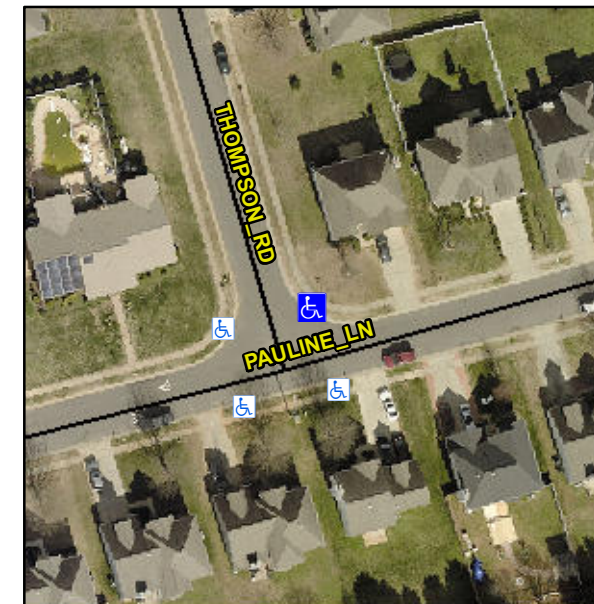
**R304.2.1, R305.2, R304.5.4**

| Compliance | Description | Data | Compliance | Description | Data |
|---|---|---|---|---|---|
| No | Landing Length (in) | 45.0 | Yes | DWS Provided? | Yes |
| N/A | Landing Curb? (Y/N) | No | No | DWS Offset (in) | 4.0 |
| Yes | Gutter Ponding? | No | No | Gutter Slope (%) | 8.5 |

**Remove & Replace Curb Ramp With Two New Directional Ramps or Equivalent. Remove & Replace Gutter.**
