Access Compliance Report

Public Rights-of-Way

(Curb Ramps)

Intersection ID: 6673	Main Street: NEVIN_RD	Cross Street: FINCHER_BV	Location: SW
ADA ID: 8D7E7991578B	Ramp Type: Perp	Initial Pass/Fail: Fail	Overall Compliance: No
Severity Score: 46.25			
Codes/Mitigation Info/Possible Solution		Field Measurements/Component Compliance

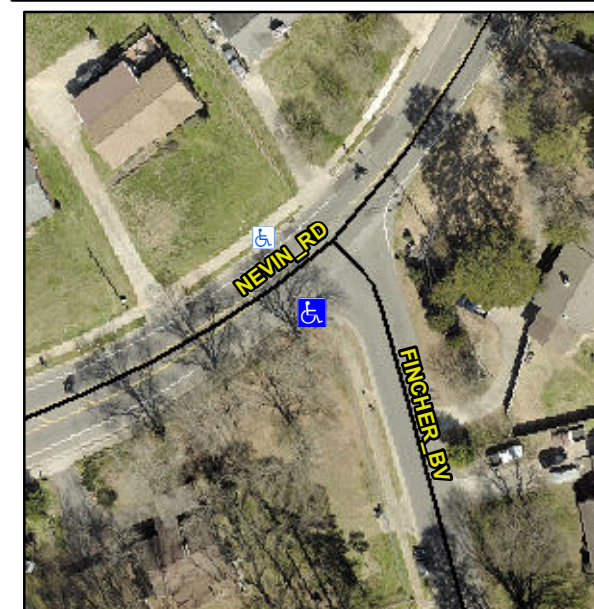
PROW/ADA:

Not Found, R304.5.1, R304.2.2, R304.5.3

Compliance	Description	Data	Compliance	Description	Data
N/A	Ramp Length (in)	105.0	No	Ramp Slope (%)	8.4
No	Ramp Width (in)	42.0	No	Ramp XSlope (%)	9.5
N/A	Flare Type LT	N/A	N/A	Flare Type RT	N/A
N/A	Flare Slope LT (%)	N/A	N/A	Flare Slope RT (%)	N/A
N/A	Flare Traversable LT?	N/A	N/A	Flare Traversable RT?	N/A
N/A	Landing Length (in)	N/A	N/A	DWS Provided?	N/A
N/A	Landing Width (in)	N/A	N/A	DWS Contrast?	N/A
N/A	Landing Slope (%)	N/A	N/A	DWS Length (in)	N/A
N/A	Landing X Slope (%)	N/A	N/A	DWS Full Width?	N/A
N/A	Landing Curb? (Y/N)	N/A	N/A	DWS Offset (in)	N/A
N/A	Shared Landing?	N/A			
N/A	Gutter Ponding?	N/A	N/A	Gutter Slope (%)	N/A
N/A	Gutter Lip Ht (in)	0.5	N/A	Gutter X Slope (%)	N/A
N/A	Painted X Walk1?	No	N/A	Painted X Walk2?	N/A
	X Walk 1 Direction	To N		X Walk 2 Direction	N/A
N/A	X Walk 1 Width (in)	N/A	N/A	X Walk 2 Width (in)	N/A
	X Walk 1 Slope (%)	8.5		X Walk 2 Slope (%)	N/A
	X Walk 1 X Slope (%)	1.4		X Walk 2 X Slope (%)	N/A

N/A	Ramp inside XWalk1?	N/A	N/A	Ramp inside XWalk2?	N/A
	Road Slope (%)	N/A	N/A	Clear Space?	N/A
	Road X Slope (%)	N/A	N/A	Clear Space to XWalk (in)	N/A
N/A	Any Obstructions?	N/A	N/A	Storm Grate/Utility Hazard?	N/A
	Obstruction Type			Storm Grate/Utility Type	
		N/A			N/A
			Yes	Surface Condition? (G/P)	Good

Possible Solutions:

Remove & Replace Entire Ramp.
