# Access Compliance Report

## Public Rights-of-Way

### (Curb Ramps)

Intersection ID: 11313	Main Street: STAFFORD_DR	Cross Street: WILKINSON_BV	Location: NW
ADA ID: 8D803B25B37C	Ramp Type: Perp	Initial Pass/Fail: Fail	Overall Compliance: No
		Severity Score: 8.75

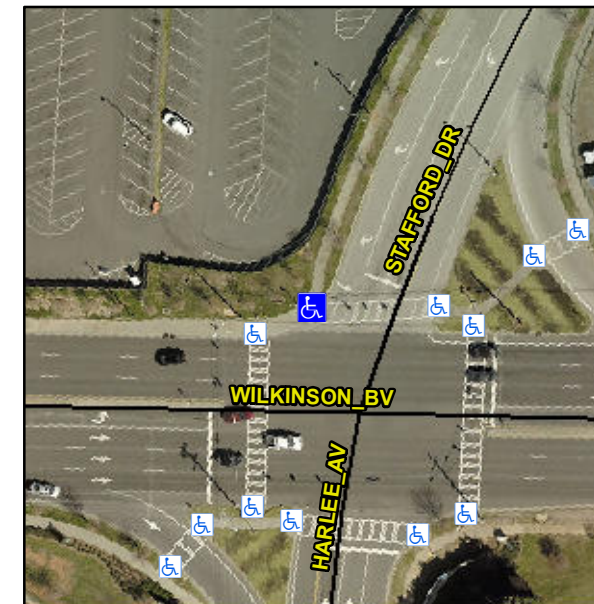
**Not Found, R304.5.1**

Compliance	Description	Data	Compliance	Description	Data
N/A	Ramp Length (in)	96.0	Yes	Ramp Slope (%)	6.6
No	Ramp Width (in)	47.0	Yes	Ramp XSlope (%)	1.0
N/A	Flare Type LT	N/A	N/A	Flare Type RT	N/A
N/A	Flare Slope LT (%)	N/A	N/A	Flare Slope RT (%)	N/A
N/A	Flare Traversable LT?	N/A	N/A	Flare Traversable RT?	N/A
N/A	Landing Length (in)	N/A	N/A	DWS Provided?	N/A
N/A	Landing Width (in)	N/A	N/A	DWS Contrast?	N/A
N/A	Landing Slope (%)	N/A	N/A	DWS Length (in)	N/A
N/A	Landing X Slope (%)	N/A	N/A	DWS Full Width?	N/A
N/A	Landing Curb? (Y/N)	N/A	N/A	DWS Offset (in)	N/A
N/A	Shared Landing?	N/A			
N/A	Gutter Ponding?	N/A	N/A	Gutter Slope (%)	N/A
N/A	Gutter Lip Ht (in)	N/A	N/A	Gutter X Slope (%)	N/A
N/A	Painted X Walk1?	Yes	N/A	Painted X Walk2?	N/A
	X Walk 1 Direction	To E		X Walk 2 Direction	N/A
N/A	X Walk 1 Width (in)	111.0	N/A	X Walk 2 Width (in)	N/A
	X Walk 1 Slope (%)	1.6		X Walk 2 Slope (%)	N/A
	X Walk 1 X Slope (%)	1.3		X Walk 2 X Slope (%)	N/A

**Remove & Replace Entire Ramp.**

Total Cost: \$ 1850.00
