# Access Compliance Report

## Public Rights-of-Way

### (Curb Ramps)

Intersection ID: 42945	Main Street: MOONDANCE_LN	Cross Street: SONOMA_VALLEY_DR	Location: NW
ADA ID: 8D8413F901C3	Ramp Type: PerpDiag	Initial Pass/Fail: Fail	Overall Compliance: No
Severity Score: 8.75			
Codes/Mitigation Info/Possible Solution		Field Measurements/Component Compliance

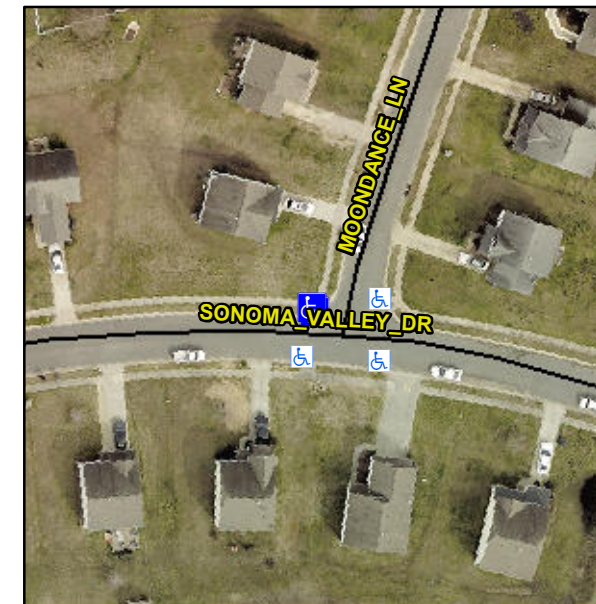
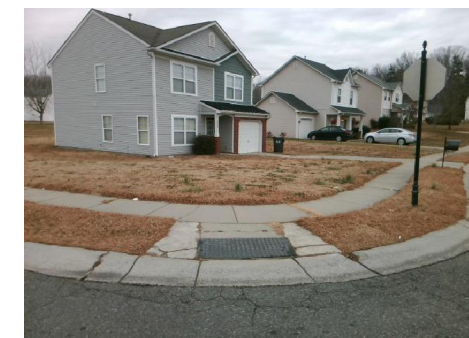
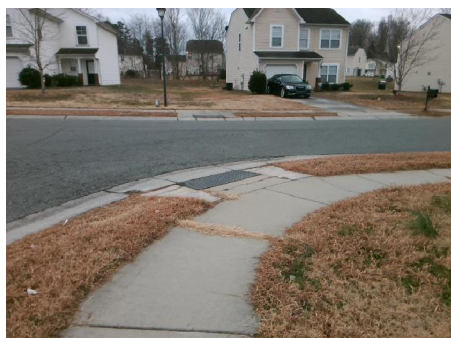
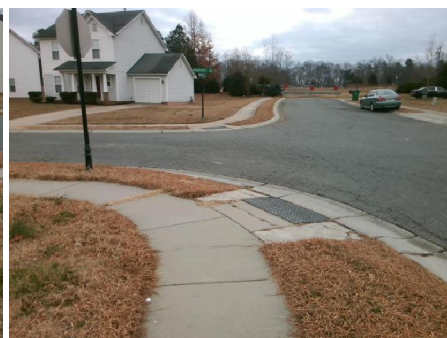
Compliance	Description	Data	Compliance	Description	Data
N/A	Ramp Length (in)	50.0	Yes	Ramp Slope (%)	7.5
No	Ramp Width (in)	46.0	Yes	Ramp XSlope (%)	0.6
N/A	Flare Type LT	N/A	N/A	Flare Type RT	N/A
N/A	Flare Slope LT (%)	N/A	N/A	Flare Slope RT (%)	N/A
N/A	Flare Traversable LT?	N/A	N/A	Flare Traversable RT?	N/A
N/A	Landing Length (in)	N/A	N/A	DWS Provided?	N/A
N/A	Landing Width (in)	N/A	N/A	DWS Contrast?	N/A
N/A	Landing Slope (%)	N/A	N/A	DWS Length (in)	N/A
N/A	Landing X Slope (%)	N/A	N/A	DWS Full Width?	N/A
N/A	Landing Curb? (Y/N)	N/A	N/A	DWS Offset (in)	N/A
N/A	Shared Landing?	N/A			
N/A	Gutter Ponding?	N/A	N/A	Gutter Slope (%)	N/A
N/A	Gutter Lip Ht (in)	N/A	N/A	Gutter X Slope (%)	N/A
N/A	Painted X Walk1?	No	N/A	Painted X Walk2?	No
	X Walk 1 Direction	To S		X Walk 2 Direction	To E
N/A	X Walk 1 Width (in)	N/A	N/A	X Walk 2 Width (in)	N/A
	X Walk 1 Slope (%)	3.5		X Walk 2 Slope (%)	3.0
	X Walk 1 X Slope (%)	1.9		X Walk 2 X Slope (%)	3.3

N/A	Ramp inside XWalk1?	N/A	N/A	Ramp inside XWalk2?	N/A
	Road Slope (%)	0.8	N/A	Clear Space?	N/A
	Road X Slope (%)	4.1	N/A	Clear Space to XWalk (in)	N/A
N/A	Any Obstructions?	N/A	N/A	Storm Grate/Utility Hazard?	N/A
	Obstruction Type			Storm Grate/Utility Type	
		N/A			N/A
		Yes		Surface Condition? (G/P)	Good

**Remove & Replace Curb Ramp With Two New Directional Ramps or Equivalent.**

**Not Found, R304.5.1**
