Access Compliance Report

Public Rights-of-Way

(Curb Ramps)

Intersection ID: 13786	Main Street: E_7TH_ST	Cross Street: LAMAR_AV	Location: W
ADA ID: 8D890CEFF446	Ramp Type: Perp	Initial Pass/Fail: Fail	Overall Compliance: No
Severity Score: 10			
Codes/Mitigation Info/Possible Solution		Field Measurements/Component Compliance

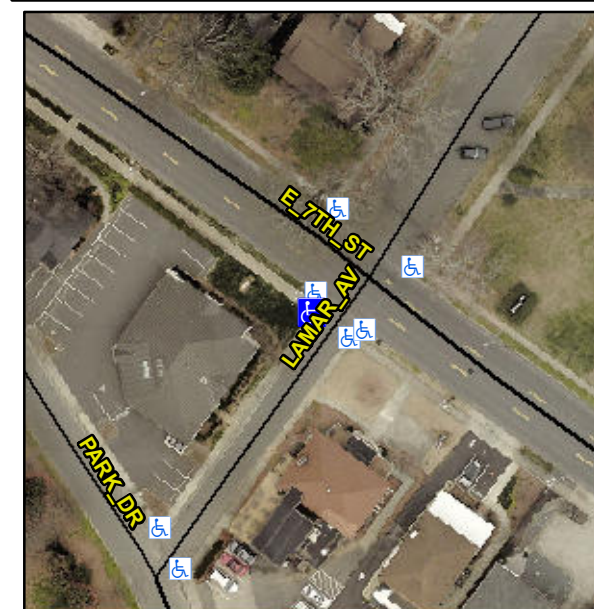
Not Found, R304.5.1, R304.5.3

Compliance	Description	Data	Compliance	Description	Data
N/A	Ramp Length (in)	25.0	Yes	Ramp Slope (%)	4.3
No	Ramp Width (in)	47.0	No	Ramp XSlope (%)	3.6
N/A	Flare Type LT	N/A	N/A	Flare Type RT	N/A
N/A	Flare Slope LT (%)	N/A	N/A	Flare Slope RT (%)	N/A
N/A	Flare Traversable LT?	N/A	N/A	Flare Traversable RT?	N/A
N/A	Landing Length (in)	N/A	N/A	DWS Provided?	N/A
N/A	Landing Width (in)	N/A	N/A	DWS Contrast?	N/A
N/A	Landing Slope (%)	N/A	N/A	DWS Length (in)	N/A
N/A	Landing X Slope (%)	N/A	N/A	DWS Full Width?	N/A
N/A	Landing Curb? (Y/N)	N/A	N/A	DWS Offset (in)	N/A
N/A	Shared Landing?	N/A			
N/A	Gutter Ponding?	N/A	N/A	Gutter Slope (%)	N/A
N/A	Gutter Lip Ht (in)	0.5	N/A	Gutter X Slope (%)	N/A
N/A	Painted X Walk1?	No	N/A	Painted X Walk2?	N/A
	X Walk 1 Direction	To SE		X Walk 2 Direction	N/A
N/A	X Walk 1 Width (in)	N/A	N/A	X Walk 2 Width (in)	N/A
	X Walk 1 Slope (%)	4.3		X Walk 2 Slope (%)	N/A
	X Walk 1 X Slope (%)	1.0		X Walk 2 X Slope (%)	N/A

N/A	Ramp inside XWalk1?	N/A	N/A	Ramp inside XWalk2?	N/A
	Road Slope (%)	N/A	N/A	Clear Space?	N/A
	Road X Slope (%)	N/A	N/A	Clear Space to XWalk (in)	N/A
N/A	Any Obstructions?	N/A	N/A	Storm Grate/Utility Hazard?	N/A
	Obstruction Type			Storm Grate/Utility Type	
		N/A			N/A
			Yes	Surface Condition? (G/P)	Good

Remove & Replace Entire Ramp.
