# Access Compliance Report

## Public Rights-of-Way

### (Curb Ramps)

| Intersection ID: 10036708 | Main Street: S_CLARKSON_ST | Cross Street: N/A | Location: N |

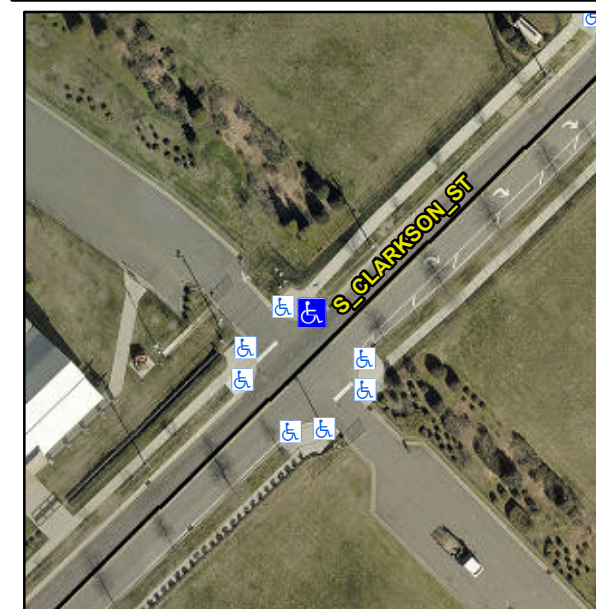
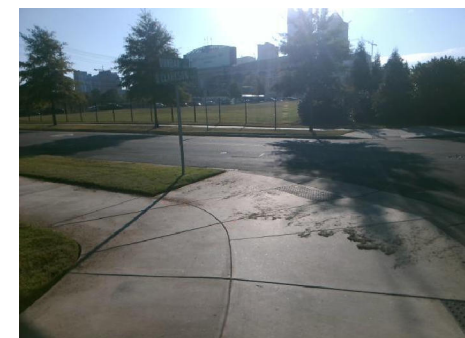
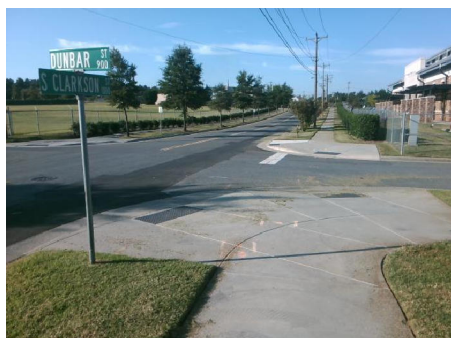
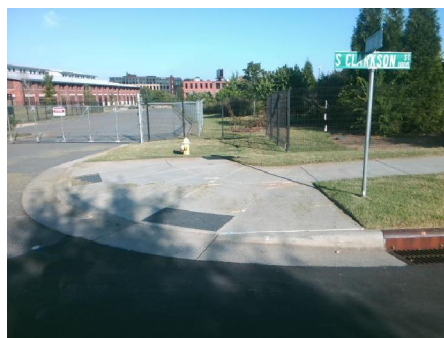
| ADA ID: 8D92026A7AD7 | Ramp Type: BlendTrans1 | Initial Pass/Fail: Pass | Overall Compliance: No |
| Severity Score: 12.75 | | | |

**R305.2, R302.7.2, R304.5.4**

| Compliance | Description | Data | Compliance | Description | Data |
|---|---|---|---|---|---|
| N/A | Landing Curb? (Y/N) | No | No | DWS Offset (in) | 4.5 |
| Yes | Gutter Ponding? | No | No | Gutter Slope (%) | 5.4 |
| No | Gutter Lip Ht (in) | 0.5 | Yes | Gutter X Slope (%) | 2.5 |

Possible Solutions:

**Remove & Replace Detectable Warning System. Remove & Replace Gutter.**

Total Cost: \$ 1550.00
