# Access Compliance Report

## Public Rights-of-Way

### (Curb Ramps)

Intersection ID: 18766	Main Street: CEDARBARK_DR	Cross Street: HUNTERS_RUN_LN	Location: SW
ADA ID: 8D93ADEBFA24	Ramp Type: PerpDiag	Initial Pass/Fail: Fail	Overall Compliance: No
		Severity Score: 37.5

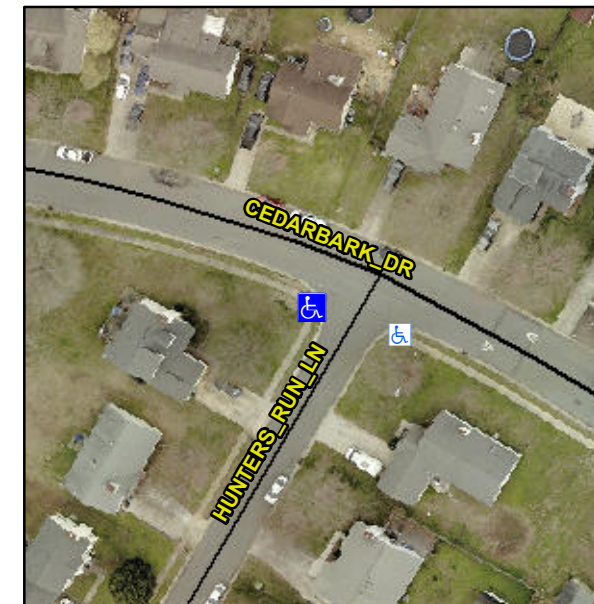
**Not Found, R304.2.2, R304.5.3**

Compliance	Description	Data	Compliance	Description	Data
N/A	Ramp Length (in)	47.0	No	Ramp Slope (%)	8.6
Yes	Ramp Width (in)	48.0	No	Ramp XSlope (%)	9.3
N/A	Flare Type LT	N/A	N/A	Flare Type RT	N/A
N/A	Flare Slope LT (%)	N/A	N/A	Flare Slope RT (%)	N/A
N/A	Flare Traversable LT?	N/A	N/A	Flare Traversable RT?	N/A
N/A	Landing Length (in)	N/A	N/A	DWS Provided?	N/A
N/A	Landing Width (in)	N/A	N/A	DWS Contrast?	N/A
N/A	Landing Slope (%)	N/A	N/A	DWS Length (in)	N/A
N/A	Landing X Slope (%)	N/A	N/A	DWS Full Width?	N/A
N/A	Landing Curb? (Y/N)	N/A	N/A	DWS Offset (in)	N/A
N/A	Shared Landing?	N/A			
N/A	Gutter Ponding?	N/A	N/A	Gutter Slope (%)	N/A
N/A	Gutter Lip Ht (in)	N/A	N/A	Gutter X Slope (%)	N/A
N/A	Painted X Walk1?	No	N/A	Painted X Walk2?	No
	X Walk 1 Direction	To SE		X Walk 2 Direction	To NE
N/A	X Walk 1 Width (in)	N/A	N/A	X Walk 2 Width (in)	N/A
	X Walk 1 Slope (%)	2.1		X Walk 2 Slope (%)	5.8
	X Walk 1 X Slope (%)	6.3		X Walk 2 X Slope (%)	1.5

N/A	Ramp inside XWalk1?	N/A	N/A	Ramp inside XWalk2?	N/A
	Road Slope (%)	7.0	N/A	Clear Space?	N/A
	Road X Slope (%)	5.5	N/A	Clear Space to XWalk (in)	N/A
N/A	Any Obstructions?	N/A	N/A	Storm Grate/Utility Hazard?	N/A
	Obstruction Type			Storm Grate/Utility Type	
		N/A			N/A
			Yes	Surface Condition? (G/P)	Good

**Remove & Replace Curb Ramp With Two New Directional Ramps or Equivalent.**

Total Cost: \$ 3200.00
