Access Compliance Report

Public Rights-of-Way

(Curb Ramps)

Intersection ID: 32144	Main Street: GREEN_CANE_DR	Cross Street: NEVERMORE_WY	Location: NW
ADA ID: 8DA03290DBF2	Ramp Type: PerpDiag	Initial Pass/Fail: Fail	Overall Compliance: No
		Severity Score: 8.75

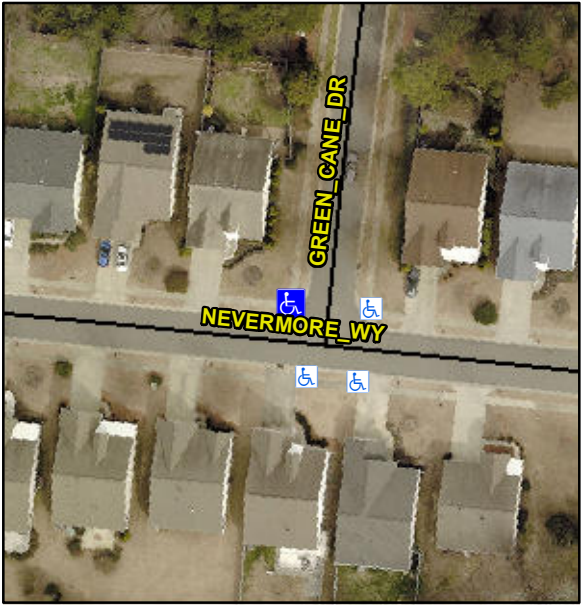
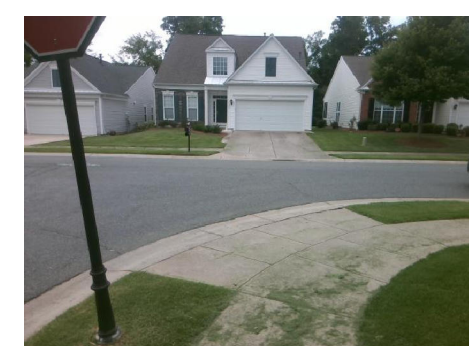
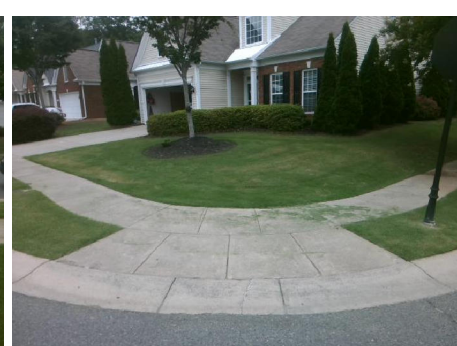
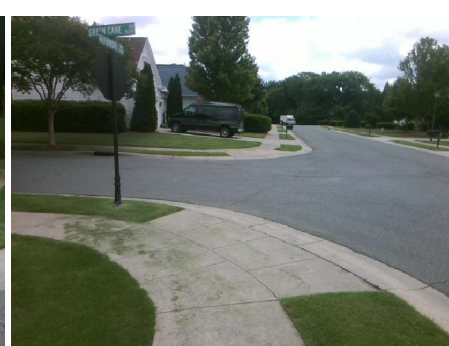
Possible Solutions:		Compliance	Description	Data
	Remove & Replace Curb Ramp With Two New Directional Ramps or Equivalent.		Yes	Ramp Length (in)	6.1
			No	Ramp Width (in)	1.0
			N/A	Flare Type LT	N/A
			N/A	Flare Slope LT (%)	N/A
			N/A	Flare Traversable LT?	N/A
			N/A	Landing Length (in)	N/A
			N/A	Landing Width (in)	N/A
			N/A	Landing Slope (%)	N/A
			N/A	Landing X Slope (%)	N/A
<p>Surveyor Notes:</p> <p>N/A</p> <p>PROW/ADA:</p> <p>Not Found, R304.5.1</p>			N/A	Flare Type RT	N/A
			N/A	Flare Slope RT (%)	N/A
			N/A	Flare Traversable RT?	N/A
			N/A	DWS Provided?	N/A
			N/A	DWS Contrast?	N/A
			N/A	DWS Length (in)	N/A
			N/A	DWS Full Width?	N/A
			N/A	DWS Offset (in)	N/A
			N/A	Gutter Ponding?	N/A
			N/A	Gutter Lip Ht (in)	N/A
<p>Total Cost:</p> <p>\$ 3200.00</p>			No	Painted X Walk1?	No
				X Walk 1 Direction	To SW
			N/A	X Walk 1 Width (in)	N/A

4.1	X Walk 1 Slope (%)	1.7
			0.3	X Walk 1 X Slope (%)	0.3
			N/A	Ramp inside XWalk1?	N/A
			1.8	Road Slope (%)	N/A
			3.9	Road X Slope (%)	N/A
			N/A	Any Obstructions?	N/A
				Obstruction Type	
			N/A	Storm Grate/Utility Hazard?	N/A
			N/A	Storm Grate/Utility Type	N/A
			Yes	Surface Condition? (G/P)	Good
